# EL VADO, MOTEL

## Structural Evaluation

Final Report August 2006

Prepared by:  
**Druc Engineering**  
1300 Luisa Street, Suite 23  
Santa Fe, New Mexico 87505

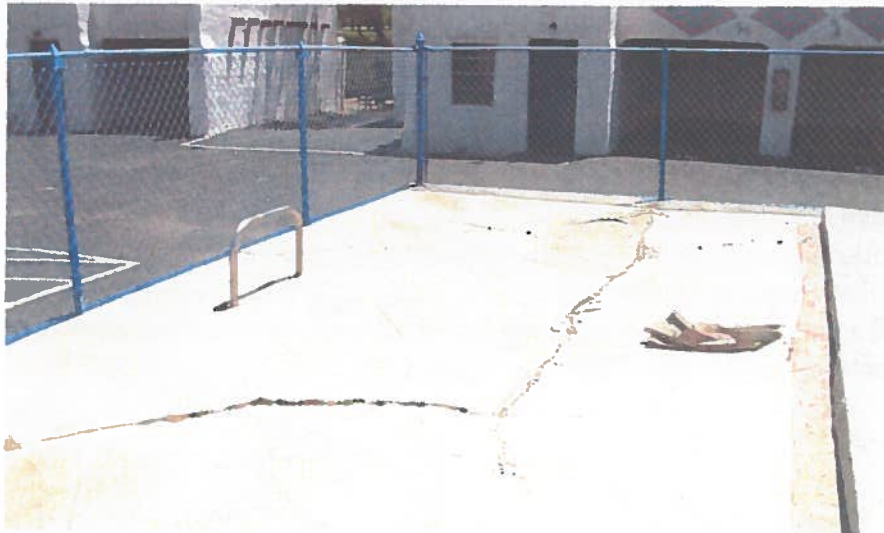
The swimming pool of the El Vado has been closed for a few years due to structural cracks in the concrete walls and decking (Figure 13). Currently the perimeter is enclosed with a chain link fence. The pool surface is covered with plywood panels and asphalt roofing. The mechanical room for the pool is also dilapidated and is out of compliance with plumbing and electrical codes.

**Figure 13 Cracked Concrete at Swimming Pool deck**

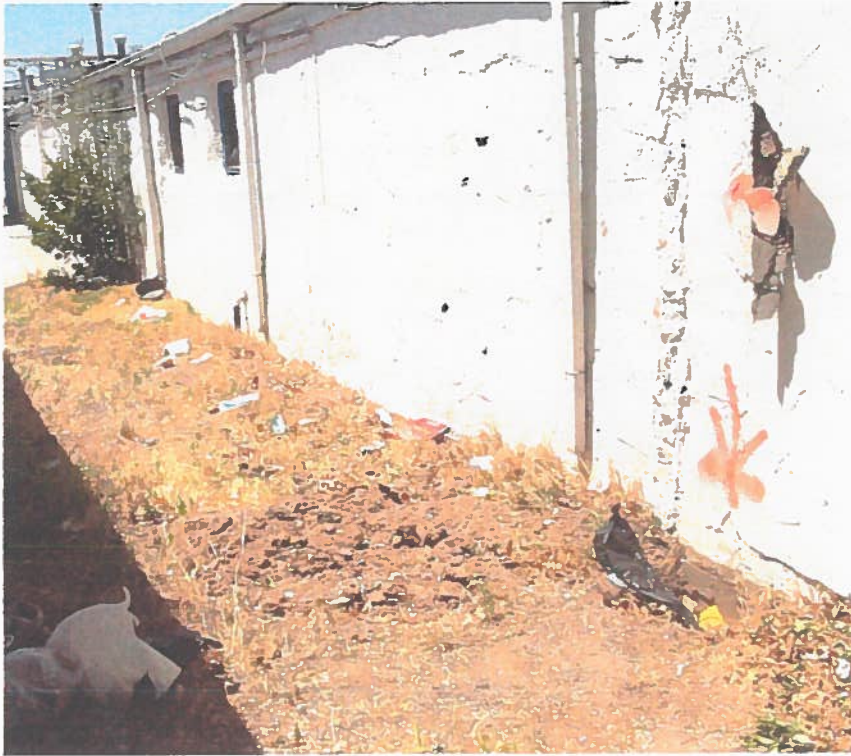
**Figure 14 Soil Level Adjacent to Wall**

Poor drainage adjacent to all the El Vado buildings, results in moisture problems such as wet walls and mold. This is a severe problem. The problem is most acute at the south walls of the south and north cluster of rooms. ***All along the walls of the buildings the level of the exterior grade is above the top of the existing concrete stem wall***, creating conditions for moisture infiltration especially into the adobe walls (Figure 14). This is a severe deficiency. The adobe blocks situated below grade absorb moisture. Wet adobes at the base of the wall have eroded and have begun to deteriorate. ***Eroded, deteriorated base adobes have been the cause of numerous adobe wall failures (Figure 15).***

- 1. The site needs to be accurately surveyed for existing elevation grades and topography to facilitate site drainage design.**
- 2. The drainage levels need to be reconfigured at a much lower elevation relative to the building foundations.**
- 3. The location of the drainage swales need to be engineered as necessary to appropriate discharge areas to avoid onsite ponding.**
- 4. Onsite drainage, needs to be redirected such that these flows do not detriment the buildings.**

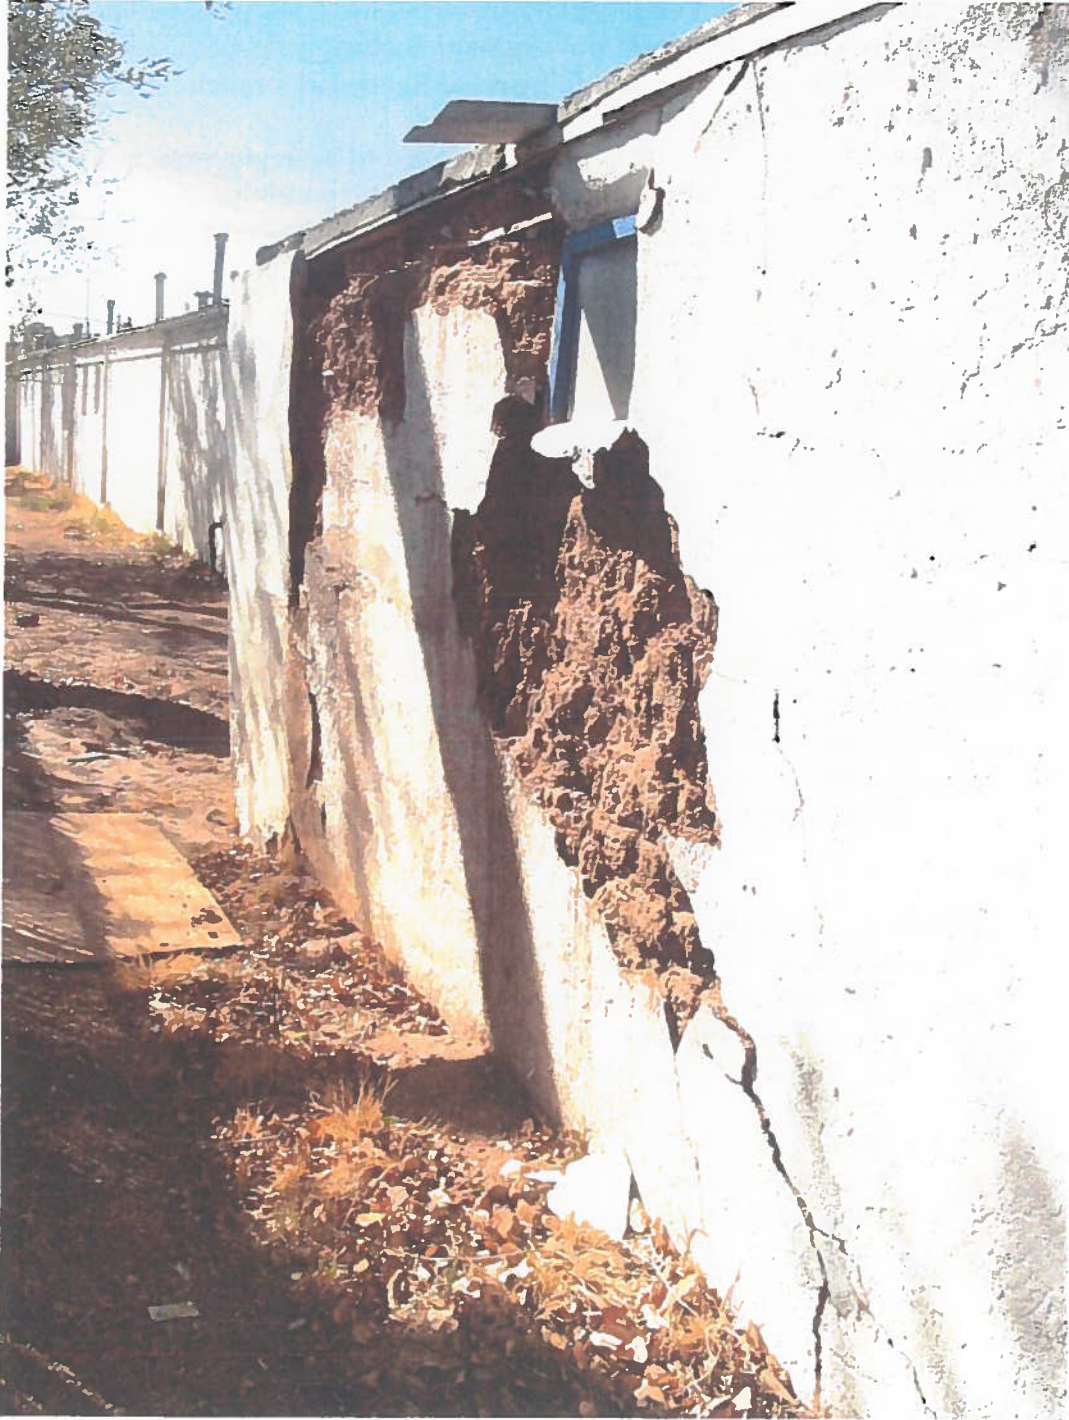
**Figure 15 Wall Failure at Southeast Building Cluster**

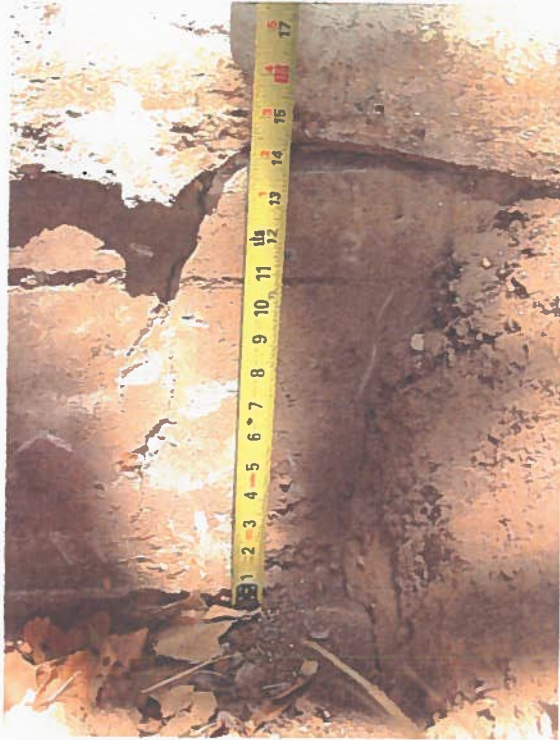
The onsite investigation hand dug a trench to expose the existing foundation. We discovered a foundation system consisting of a monolithic turn down slab (*See Figure 16*). *Our investigation found that the footing width is adequate but the depth of the footing to the frost line is inadequate.* The footings are in fair condition, however, there are signs of building settlement at various footing sections. The stem walls are not waterproofed. The investigation did not discover any foundation drains.

**Figure 16 Foundation Wall**

- 1. The soils adjacent to the footing need to be lowered so that all adobes are above finish grade. Offsite drainage to the south needs to be mitigated.**
- 2. The footing wall needs to be waterproofed and insulated by an approved method. A foundation drain should be installed adjacent to the footing. An approved design should include a drain pipe, with an appropriate geotextile to prevent clogging, and appropriate placed gravel to direct moisture into the drain. The drain should run down at an appropriate slope out to daylight.**
- 3. Downspouts and gutters need to be cleaned, prepared and sealed.**
- 4. Leaders should be installed to divert water away from the building foundation.**
- 5. The roof needs to be reconstructed to provide appropriate overhangs, parapets and flashing.**

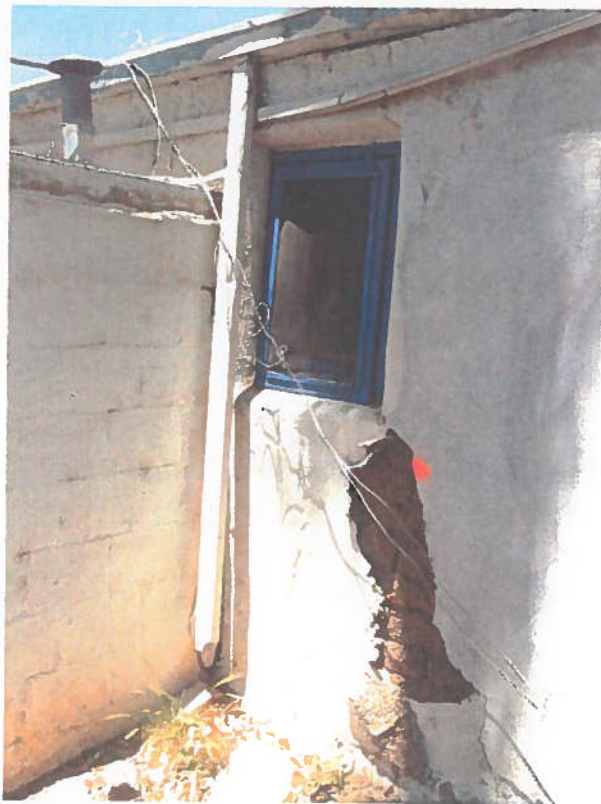
Rainwater from all the roofs drain onto the site with a system of gutters and downspouts. There are no roof overhangs in any of the roofs. The existing gutters are integrated onto the to roof edge and are contributing to water leaks that seep between the walls an cement stucco (*Figure 17*). *This is a serious deficiency.*

**Figure 17 Roof Gutters/Downspout**

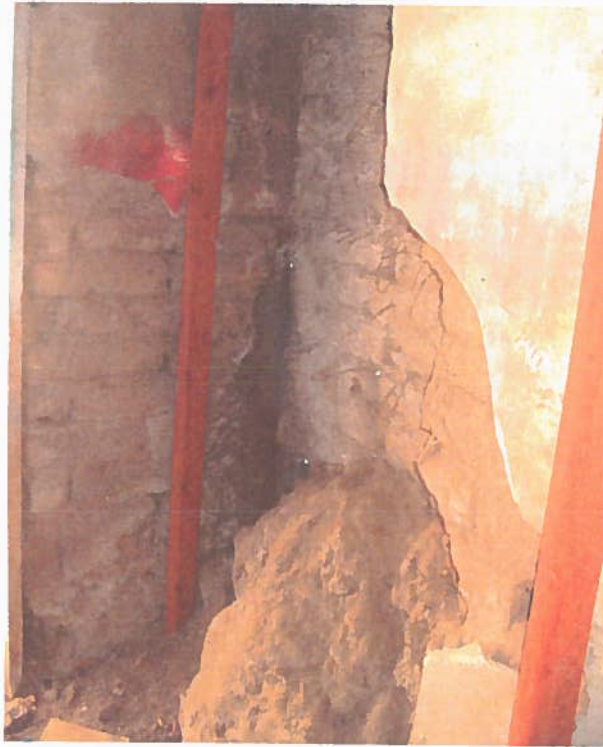
The southwest building (Building 3, Figure 9) has several low spots where storm water has been pooling near the foundation perimeter. This is especially critical at the adobe storage shed addition where there has been intensive moisture damage from the leaking gutters and damp ground leading upwards to the base of the adobe walls. As a result of the moisture saturation, the adobe walls at the storage sheds have collapsed.

**Figure 19 Collapsed Storage Shed Adobe Walls**

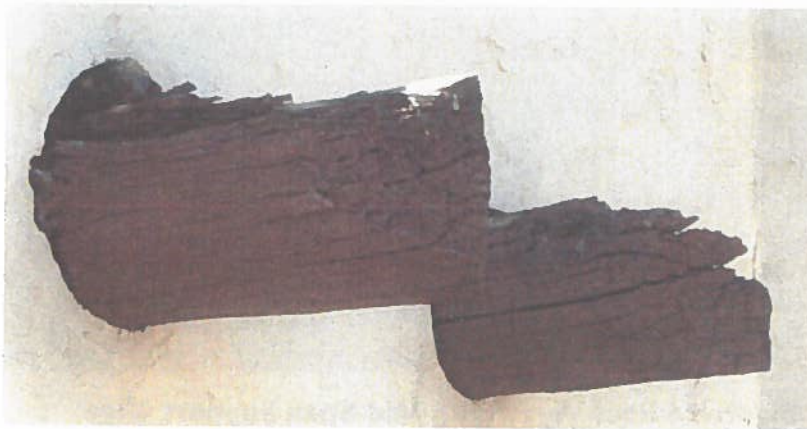
The roofing surface is in poor condition with several patched spots throughout causing water pooling and subsequent damaged. Due to the large number of roof penetrations from the utility lines there are numerous leaks throughout all roof surfaces. It seems that repairs were made to the roofing at numerous times. We noticed soft spots on the roof indicating possible failure of the roof sheathing. Some minor deflection was observed throughout portions of the roof.

**Figure 22 Dry Rot Viga Ends**

- 1. Inspect and evaluate each viga end throughout the buildings to check for rot and repair as necessary.**
- 2. Inspect and evaluate each viga for stress cracks, excessive deflection and repair as necessary.**
- 3. Inspect and evaluate roof sheathing. Replace with 3/4 inch sheathing as necessary.**
- 4. Insulate roofs to code standards and replace entire roof surfaces.**
- 5. Overhangs, gutters etc.**

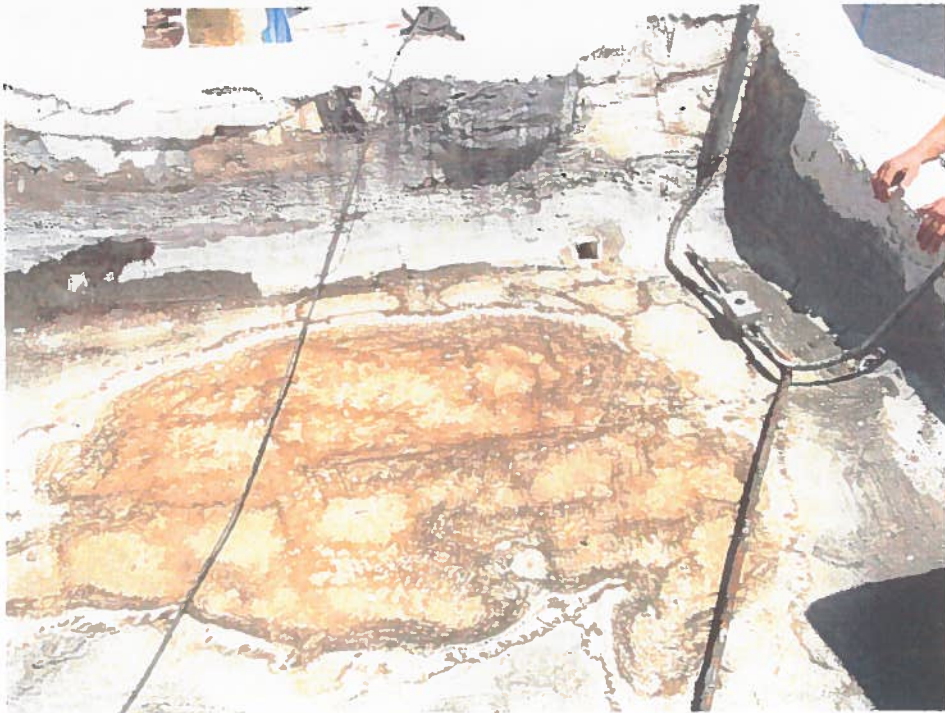
**Figure 27 Low Spot in Lobby Roof**

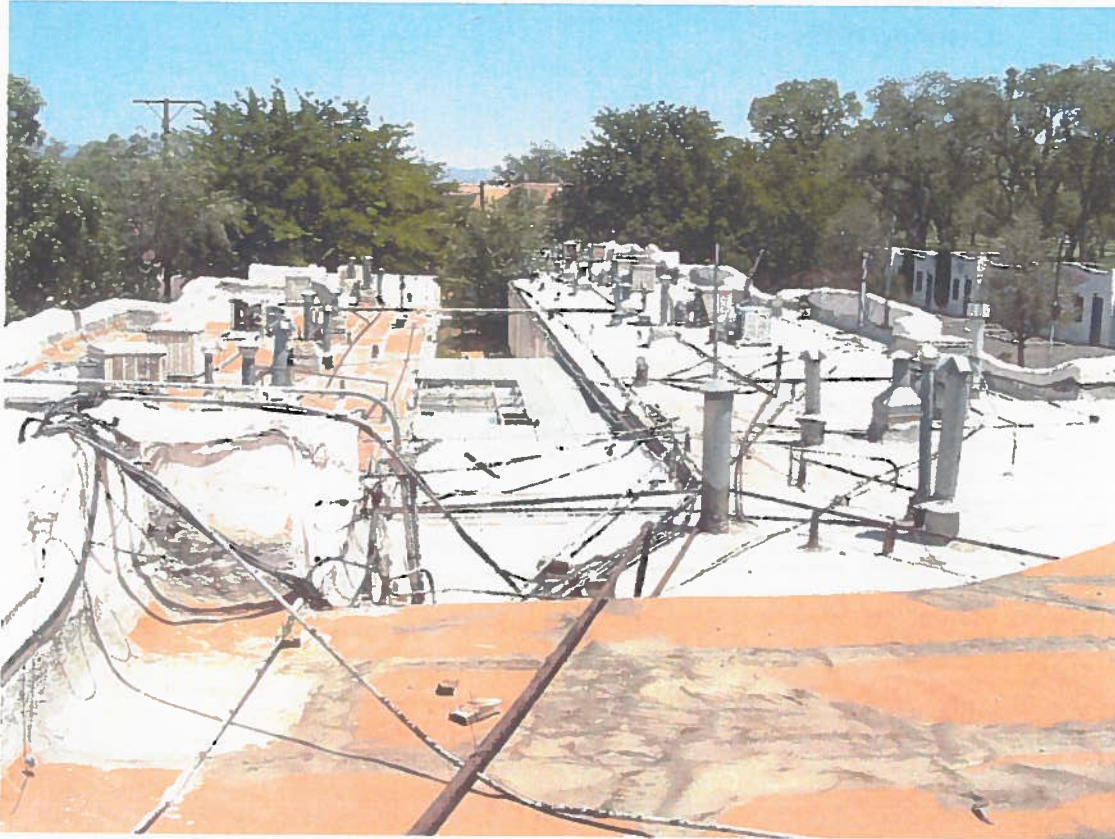
**Figure 28 Roof Penetrations at North Room Block**

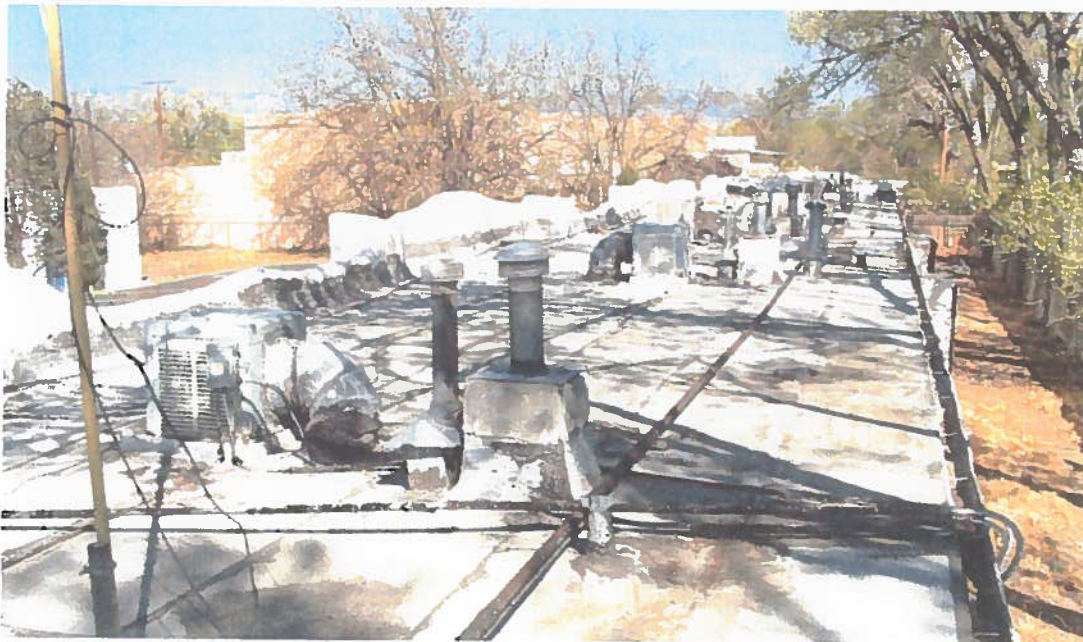
**Figure 29 Roof Penetrations at South Room Block**

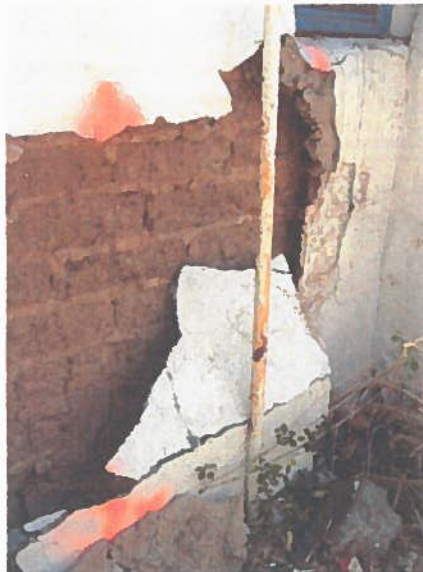
At some locations the adobe is powdery, indicating that the walls have been through numerous cycles of becoming wet and drying out. When adobes are powdery they lose their strength and are in danger of failing. There was an appearance of slumping due to the fact that there are air spaces between the layers of cement stucco (which is bulging out) and the adobe block (*Figure 37*).

**Figure 37 Cement Stucco at North East Adobe Wall**

- 1. A detailed inspection and evaluation of the stucco condition should be conducted**
- 2. Perform site and grading recommendations as listed in the above sections.**
- 3. Remove all cement stucco at areas where stucco appears to be slumped.**
- 4. Remove all cement stucco at any areas where the stucco is loose or where there are major cracks.**
- 4. If possible, remove all the cement stucco from the exterior of the adobe buildings throughout. Since the cement stucco is actually a problem, it would be a good idea to remove it everywhere. The cement stucco is very hard and is adhered to the adobes. Removing the stucco might cause the adobes to crack and fall apart.**
- 5. Replace cement stucco with an approved material, such as a lime-based stucco which will allow the wall to "breathe".**

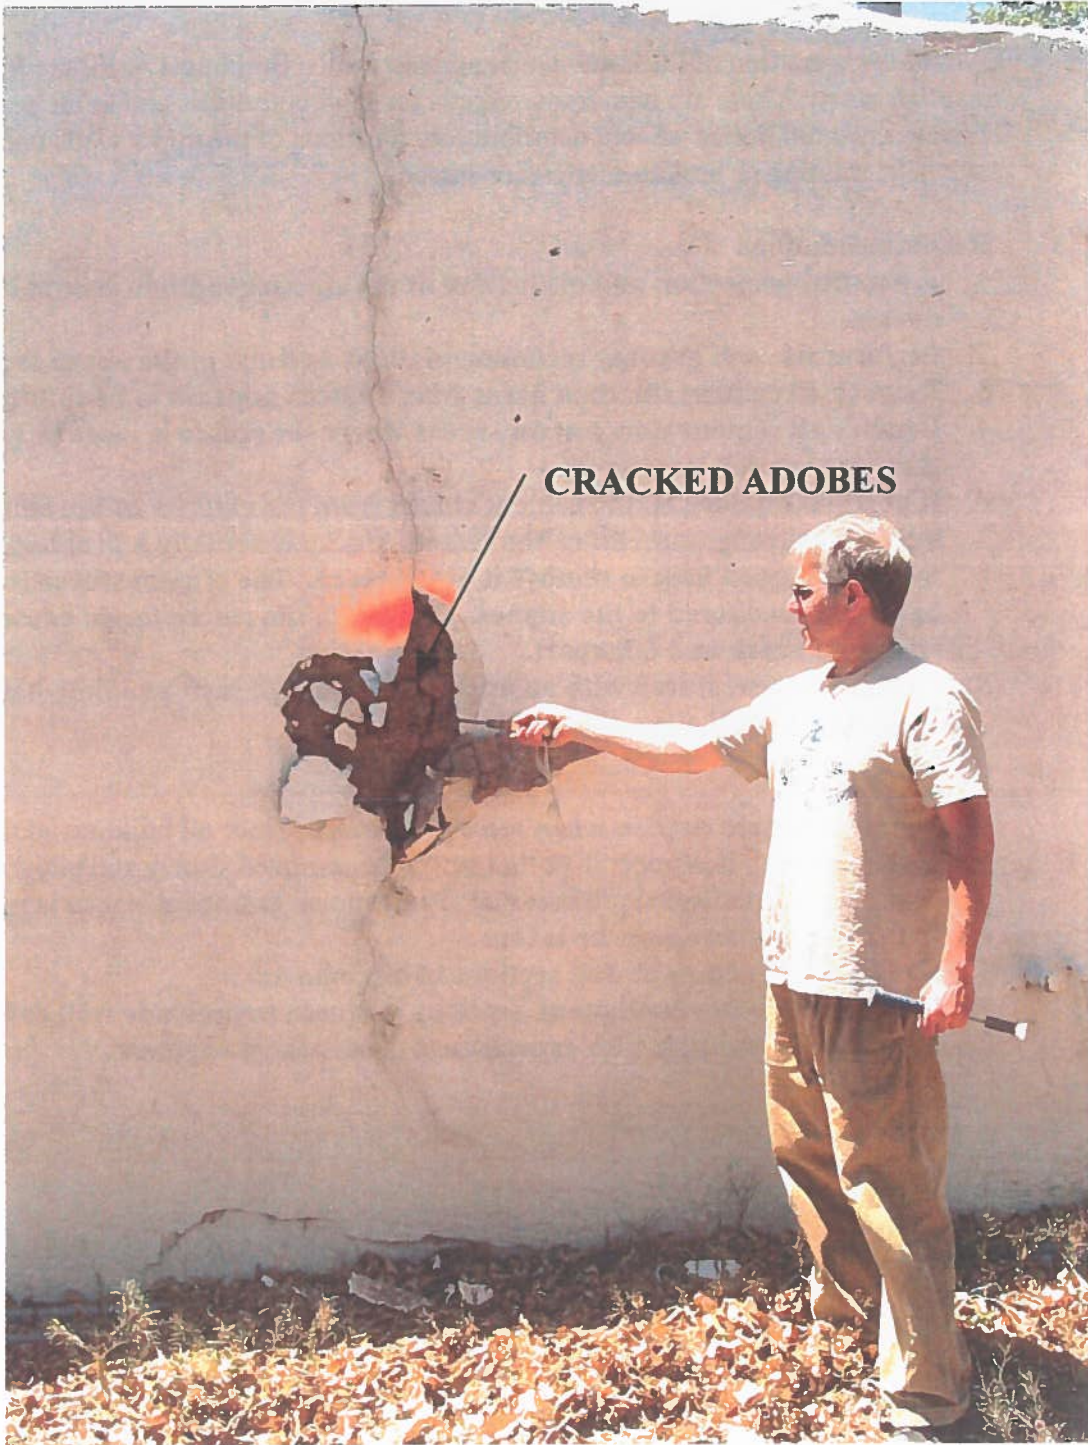
**Figure 38 Structural Adobe Wall Separation and Stucco Crack East Adobe Wall**

- 1. Shore roof structure at wall sections to be removed.**
- 2. Remove small non-contiguous sections of stucco to preclude wall collapse.**
- 3. Access wall condition with experienced professional engineer.**

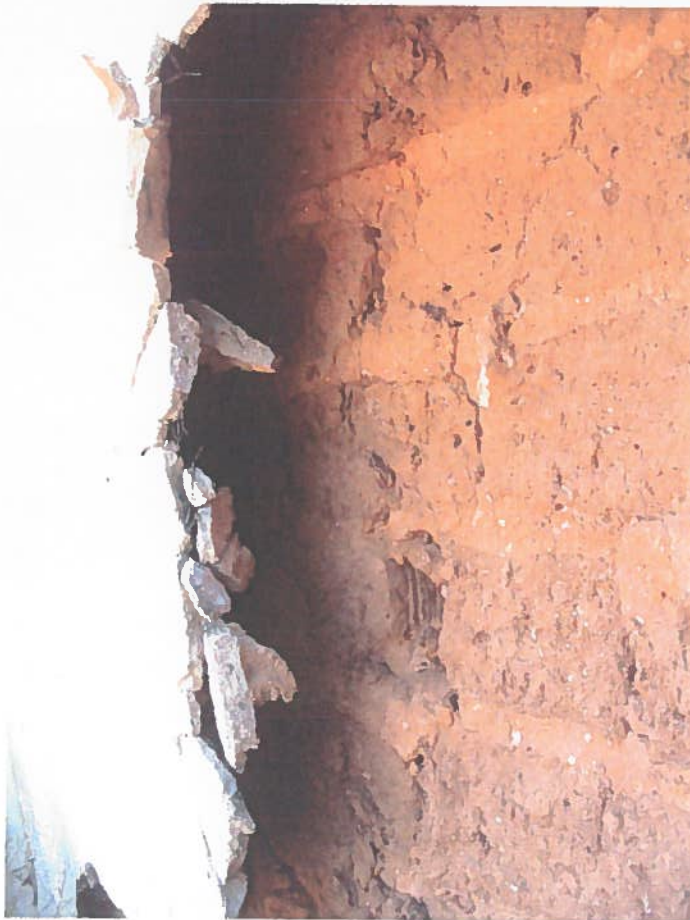
A severe condition that requires immediate attention occurs adjacent to the parapet wall on the north side of the building. The damage occurring is due to moisture infiltration because of cracked stucco which allows moisture in between the adobe walls and cement plaster. The moisture becomes trapped and cannot get out. The adobe blocks become saturated with the moisture and begin to deteriorate. As the blocks deteriorate, chunks of adobe mud and mortar separate from the rest of the block. This creates a larger void between the cement stucco and the adobe, giving access for snow melt and rain to enter the cavity. The adobe chunks become wedged between the intact wall and the cement plaster causing a further cycle of deterioration. As trapped moisture freezes and expands it creates even more damage as the cement stucco is forced away from the building dragging pieces of adhered adobe with it.

The north wall is now at the point where large sections of cement plaster are falling off the building. **This constitutes a dangerous, severe existing condition.** Exposed adobe walls, cracked stucco and wall damage at the northeast as evident by the bulging stucco and separated concrete apron.

**Figure 39 - Cement Stucco Separation from Adobe Wall**

- 1. Remove all the loose cement stucco from the wall area. (Risk of wall failure in remediation effort to removing stucco is extremely probable).**
- 2. Remove all the loose adobe block from the area.**
- 3. Repair all compromised adobes with new adobes interwoven with the stable existing ones.**
- 4. Retouch the adobe blocks with mud mortar to fill in all the gaps.**
- 5. Re-stucco with an approved material such as lime-plaster.**

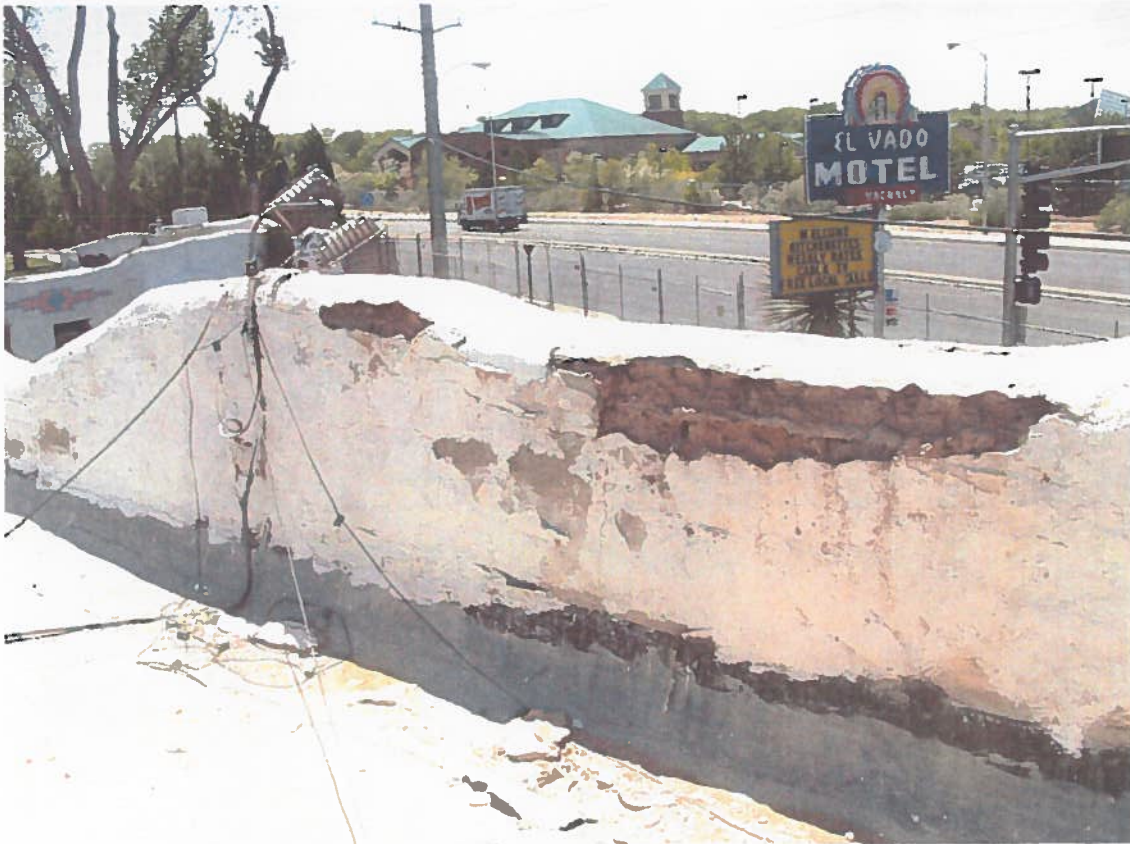
**Figure 40- Parapet at the Office/Lobby Building Showing cracks in the cement stucco where moisture enters the walls of the building, causing severe deterioration.**

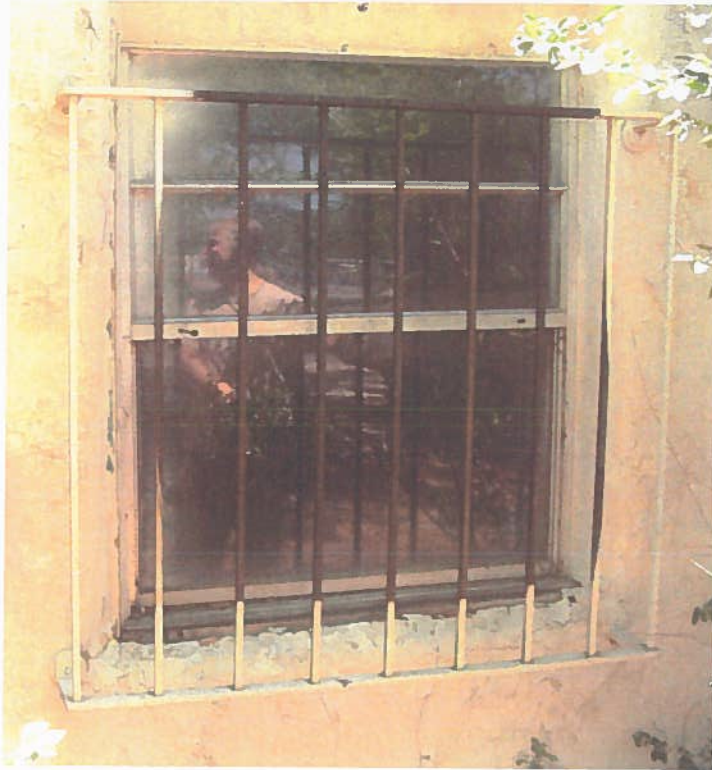
**Figure 45 - Single Hung Window With Security Bars**

***The overall condition of the windows are poor. Numerous repairs and replacement is required.*** The paint is peeling and is in poor condition. Entry doors and interior doors need refinishing.

1. **Inspect, repair and or replace exterior doors.**
2. **Inspect, repair and or replace windows.**
3. **Door hardware should comply with accessibility standards.**
4. **Door trim needs to be refinished or replaced to original finish.**
5. **New energy efficient windows and doors are recommended.**
6. **Inspect, repair or replace single hung windows to original integrity. Frames and trim are included in this procedure.**
7. **Replace bathroom window with new window comparable to original opening and style to include energy efficient glass.**
8. **Repair or replace concrete sills and paint.**
9. **Restore original window openings, install new frames windows comparable to existing windows.**
10. **Patch and repair around all window frames.**
11. **Incorporate new door hardware, include security locks.**
12. **Handicap requirements.**
