Annual Report Format

National Pollutant Discharge Elimination System Stormwater Program MS4 Annual Report Format

NMR04A014 City of Albuquerque

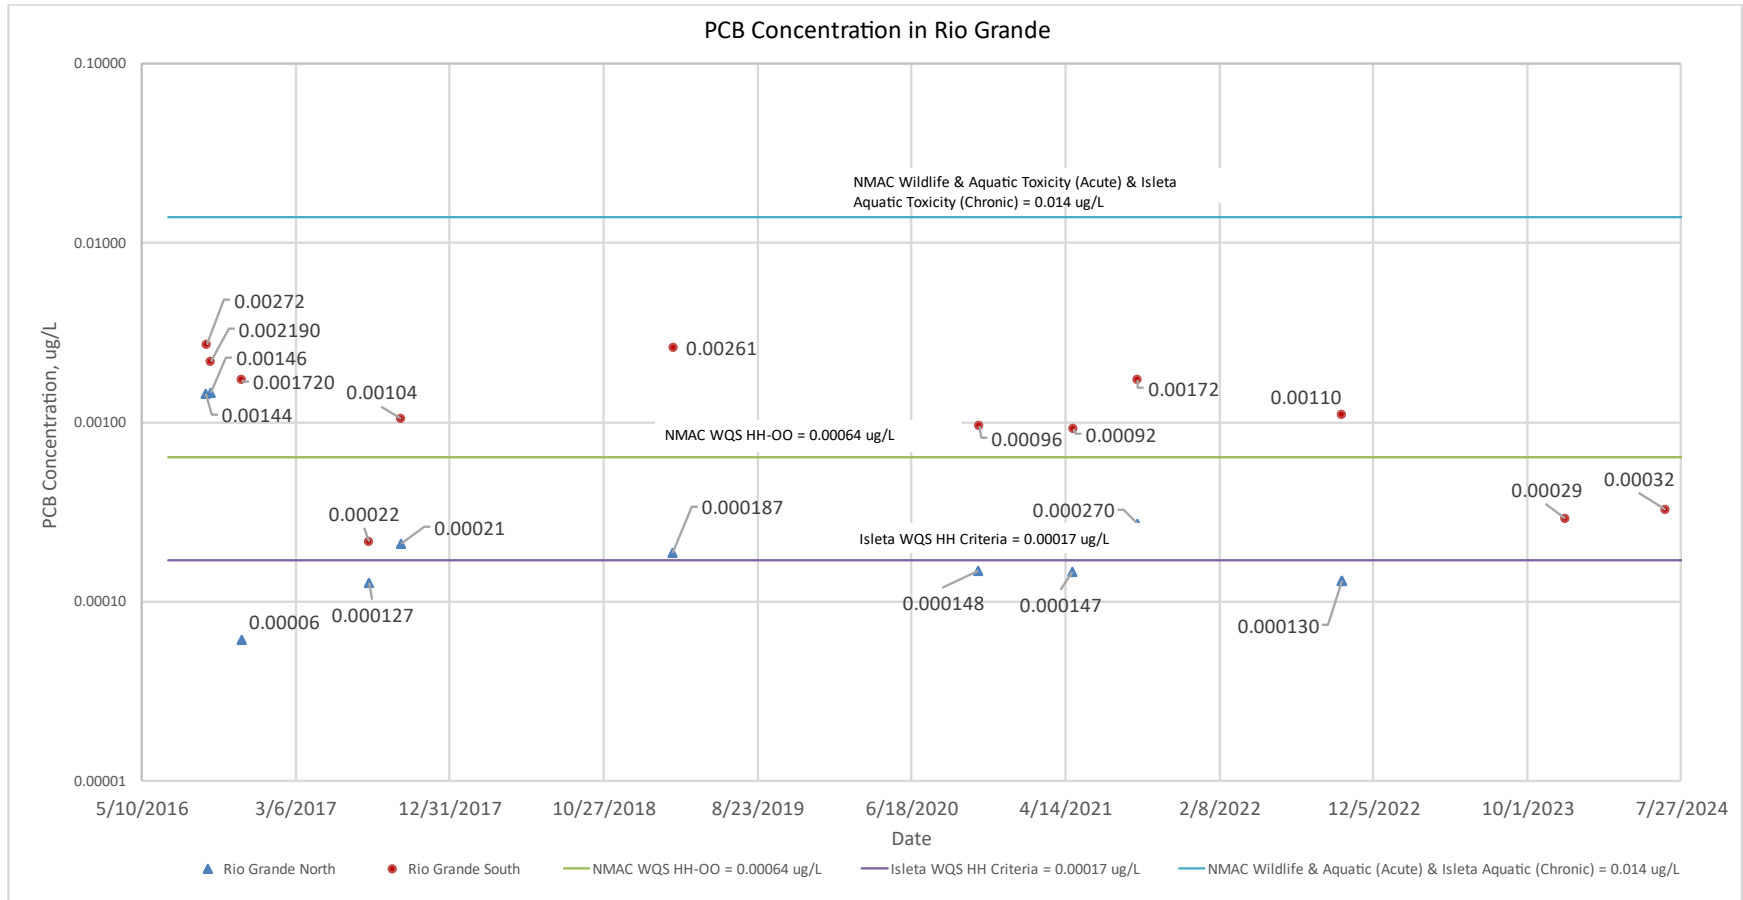
**Figure 3: PCB Monitoring Results in Rio Grande
 CMC Monitoring – 2016 - 2024**

There are multiple surface WQS values listed for PCBs in both the Pueblo of Isleta and the State of New Mexico standards for the various designated uses. The PCB results for samples collected from the Rio Grande during the FY 2024 dry season stormwater events were below the minimum quantification level (MQL) established in EPA standards for the MS4 NPDES Permit (Appendix F, 0.2 ug/L for PCBs). PCBs were not detected for the both the December 2023 and June 2024 Rio Grande North samples. However, both samples from the Rio Grande South location were above the Pueblo of Isleta human health criteria (based on fish consumption only) WQS for surface waters. The human health-organism only criterion is based upon human consumption of fish and other aquatic life that bioaccumulate contaminants over time. The PCB results from 2016 through 2024 are shown in Figure 3, relative to several of the WQSs for PCBs.

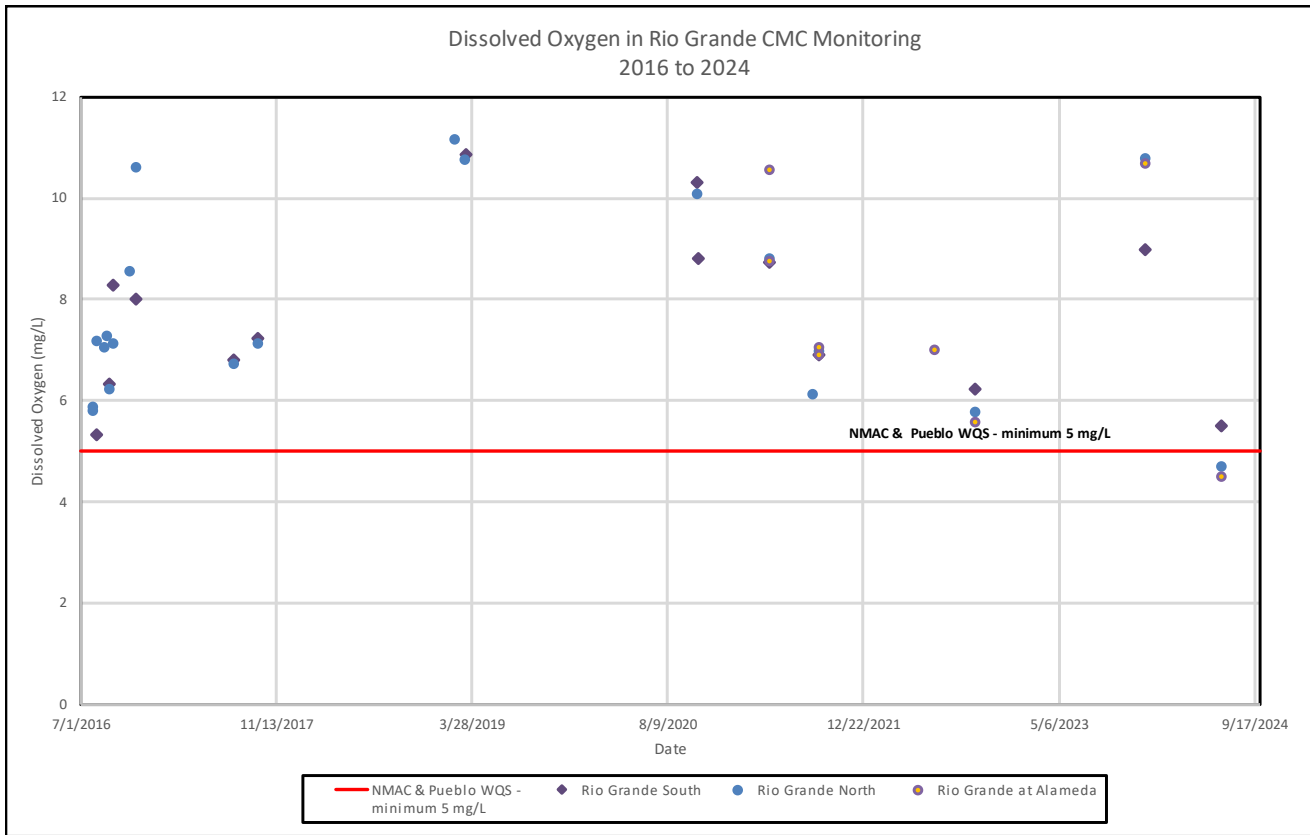
Figure 4: Dissolved Oxygen (DO) Monitoring Results in the Rio Grande CMC Monitoring – 2016 – 2024

This provides the MS4s with specific monitoring data showing that stormwater did not cause or contribute to exceedances of applicable DO WQSs in the Rio Grande from any of the CMC samples from 2016 to 2024. Refer to Figure 4 for CMC DO results and comparison to applicable WQSs.

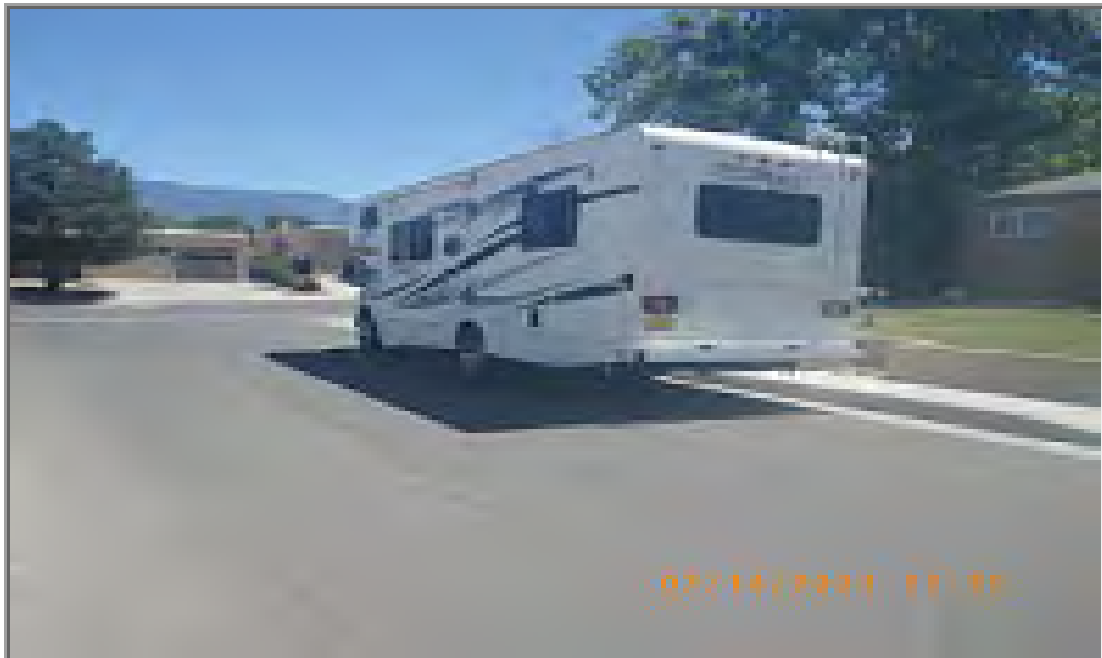
Address **7528 CAPULIN RD NE**

Field Observation THE WHITE RESIDUE WAS THE WASH WATER FROM CLEANING THE LANDSCAPE GRAVEL

Initial Action ASKED THE RESIDENT NOT TO RELEASE ANY DIRTY WATER TO STREET. ALSO DISTRIBUTED POLLUTION PREVENTION BROCHURES AT THIS AREA

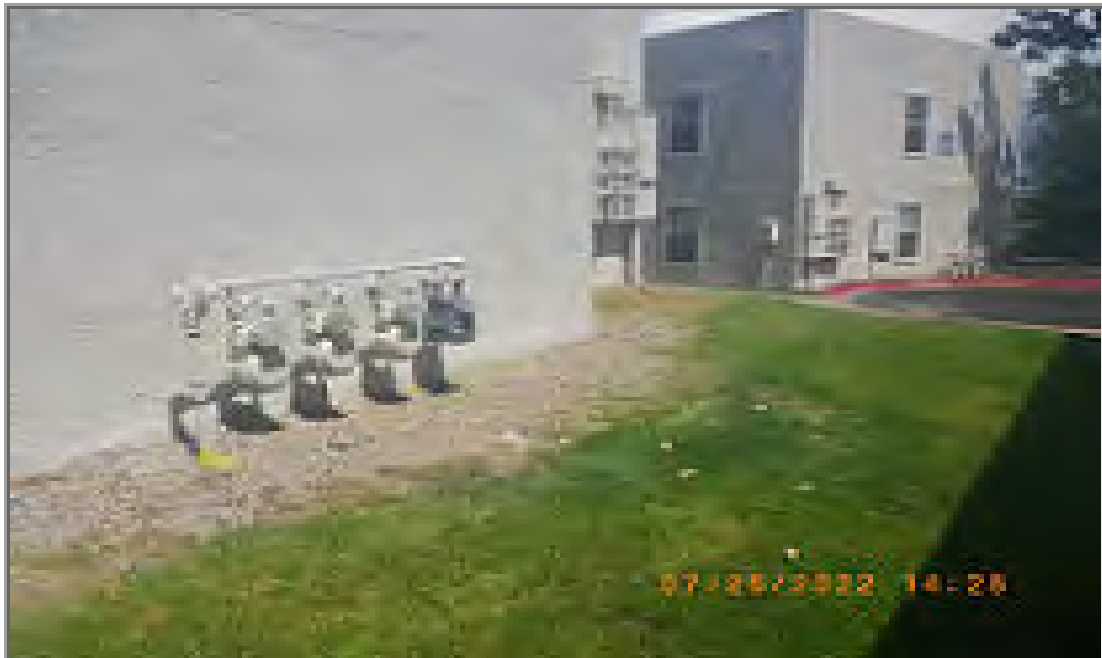
Address **EXPO NM AT LOMAS AND SAN PEDRO**

Field Observation **IT WAS FIXED AND THE AREA WAS DRY**

Initial Action **NO ACTION**

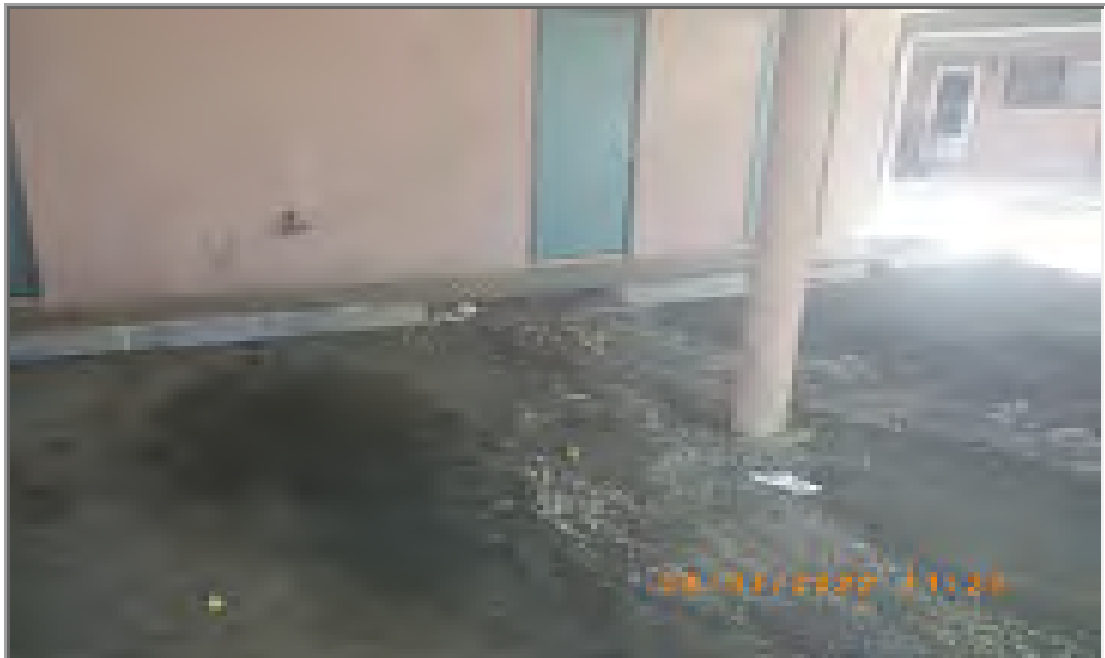
Address **1401 FREEMAN NW**

Complaint HOUSE SIDE SEWER GOING INTO THE STREET AND GOING INTO STORM DRAIN. CODE ENFORCEMENT NEEDS TO BE CONTACTED AGAIN ON THIS ADDRESS WHICH HAS BEEN LEAKING FOR ABOUT A MONTH NOW.

I SPOKE TO THE MANAGER AND HE SAID THE PLUMBER IS COMING TO FIX IT TODAY.

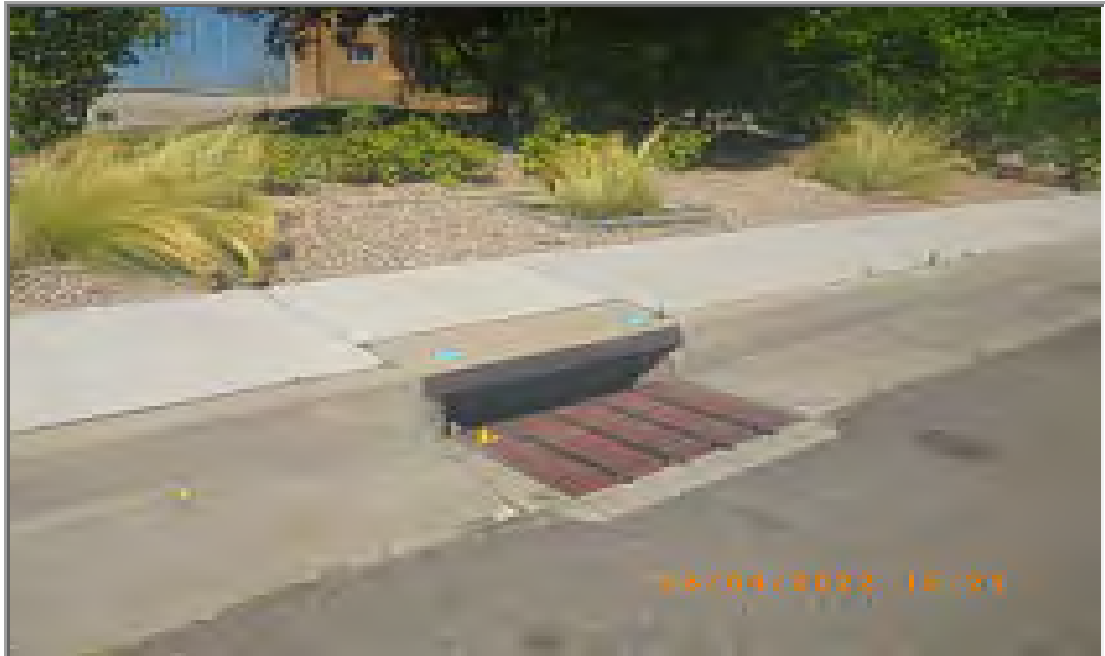
Address **AZ AUTOMOTIVE AT 4906 JEFFERSON NE**

Field Observation ALL THE INLETS WERE DRY AND NO FOUL ODOR WAS COMING FROM THE INLETS.

Initial Action DISTRIBUTED EDUCATIONAL MATERIAL AT THIS AREA AND GLUED NO DUMP SIGNS ON THE INLETS.

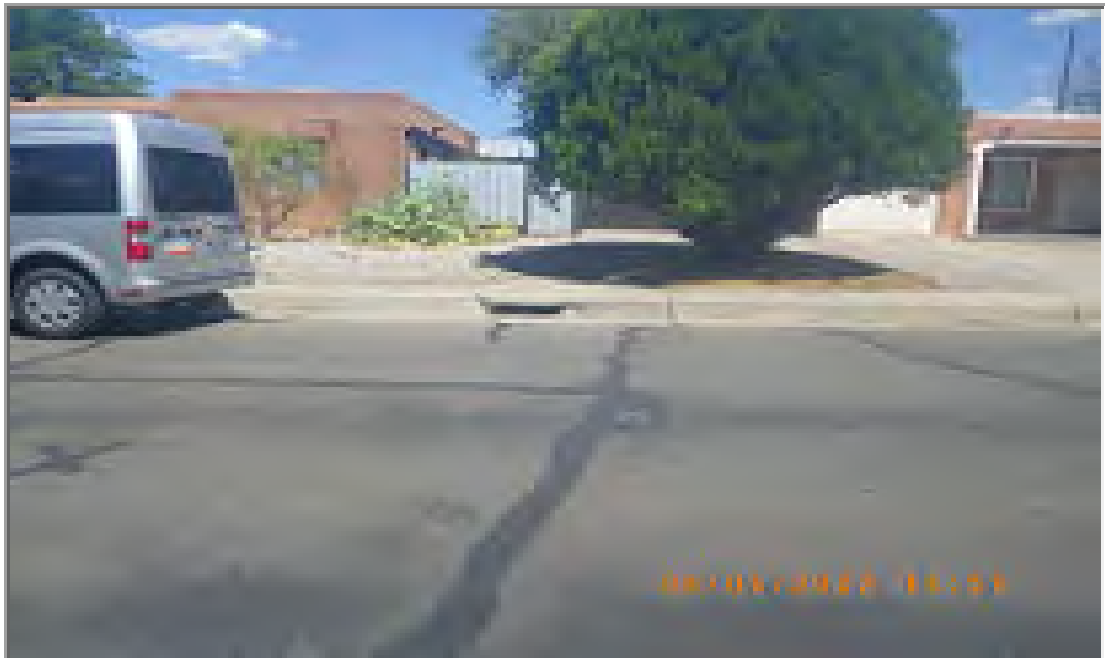
Address

Field Observation WATER WAS COMING OUT FROM A SIDEWALK CULVERT BETWEEN THE TWO HOUSES

Initial Action SPOKE TO BOTH RESIDENTS AND THEY SAID THAT THEY DO NOT KNOW WHERE THE WATER IS COMING FROM

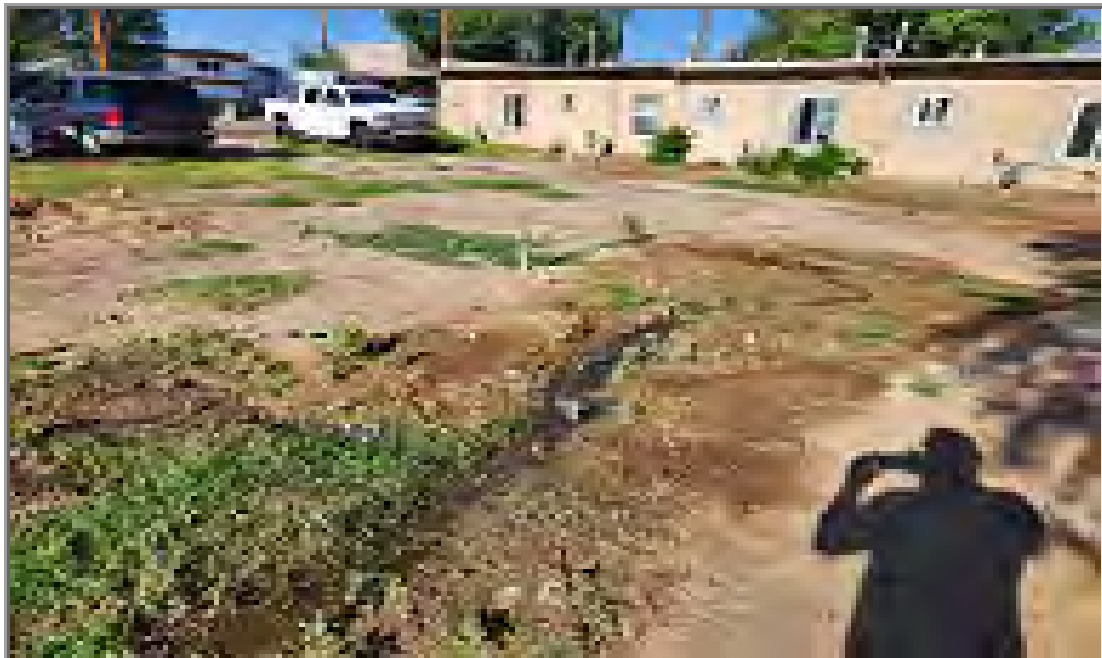
Address **2400 BROADWAY SE**

Field Observation IT WAS A WATER LEAK WHERE A TRAILER USED TO BE. DAMAGED WATER LINE.

Initial Action WE INSPECTED THE AREA AND SPOKE WITH PROPERTY MANAGER REPAIRED THE LEAK ON THE SAME DAY.

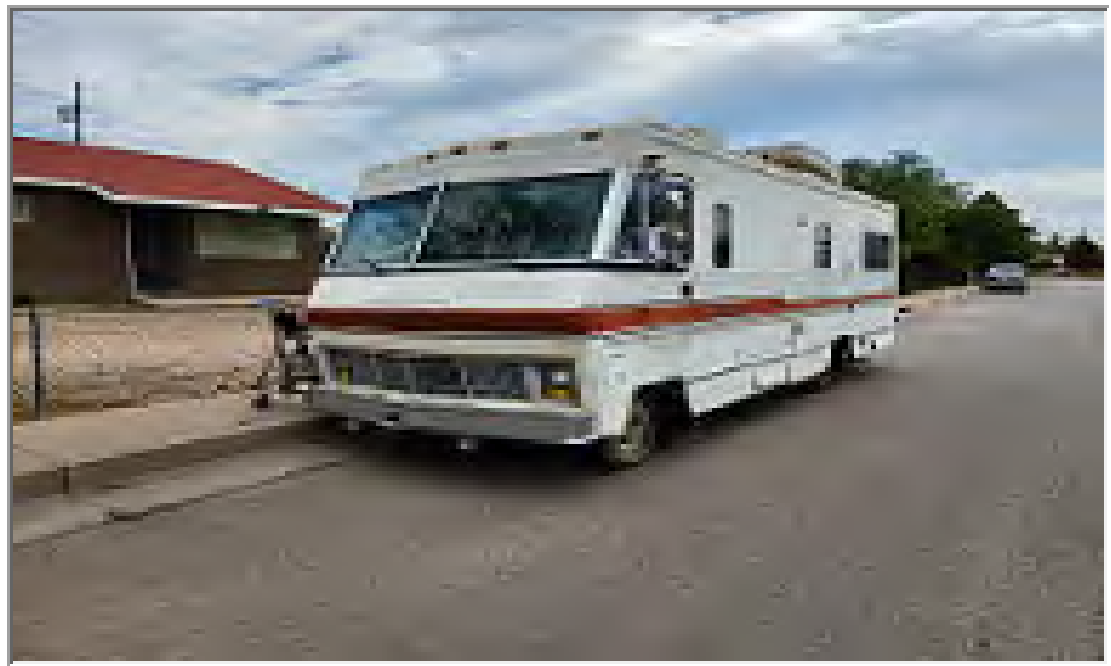
Address **344 GROVE SE**

OIL AND GASOLINE LEAK OUT OF THE RV BOTTOM. TOILET DRAINS ONTO SIDEWALK AND TO THE DRAINS ALONG THE STREET WHEN IT RAINS

REPORTED TO 311 AS ABONDEND VEHICL

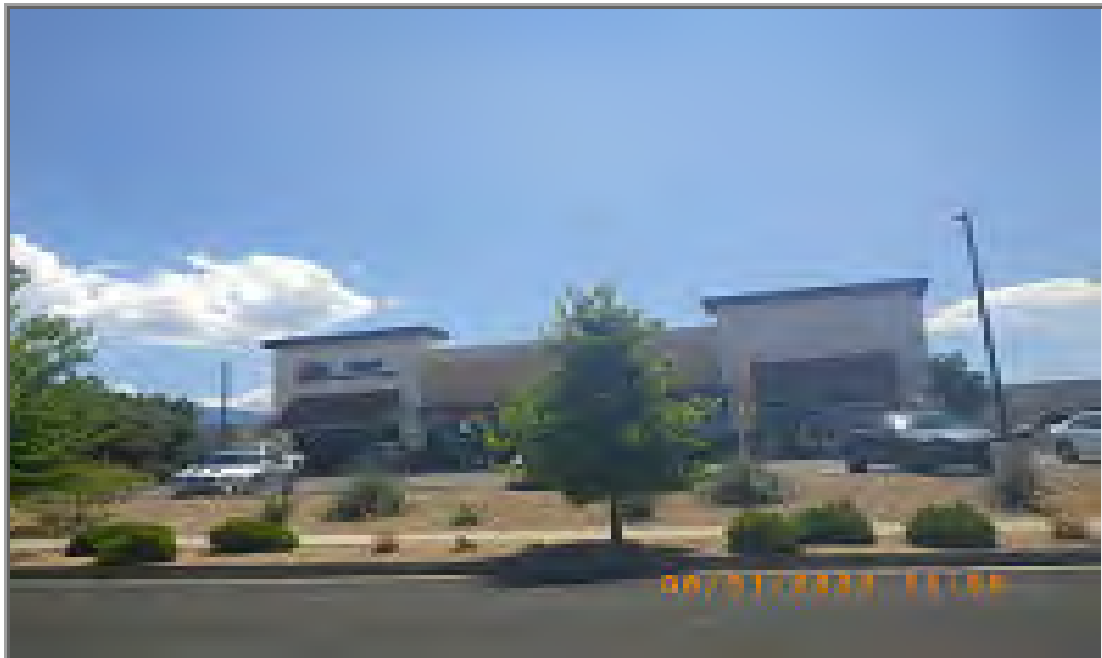
Address

THE BUSINESS LOCATED AT 5935 WYOMING BLVD NE HAS A PRIVATE SEWER LINE LEAKING IN THE STREET AND GOING DOWN THE STORM DRAIN.

UNABLE TO LOCATE THE LEAK, THIS MALL IS TOO BIG.

NO ACTION

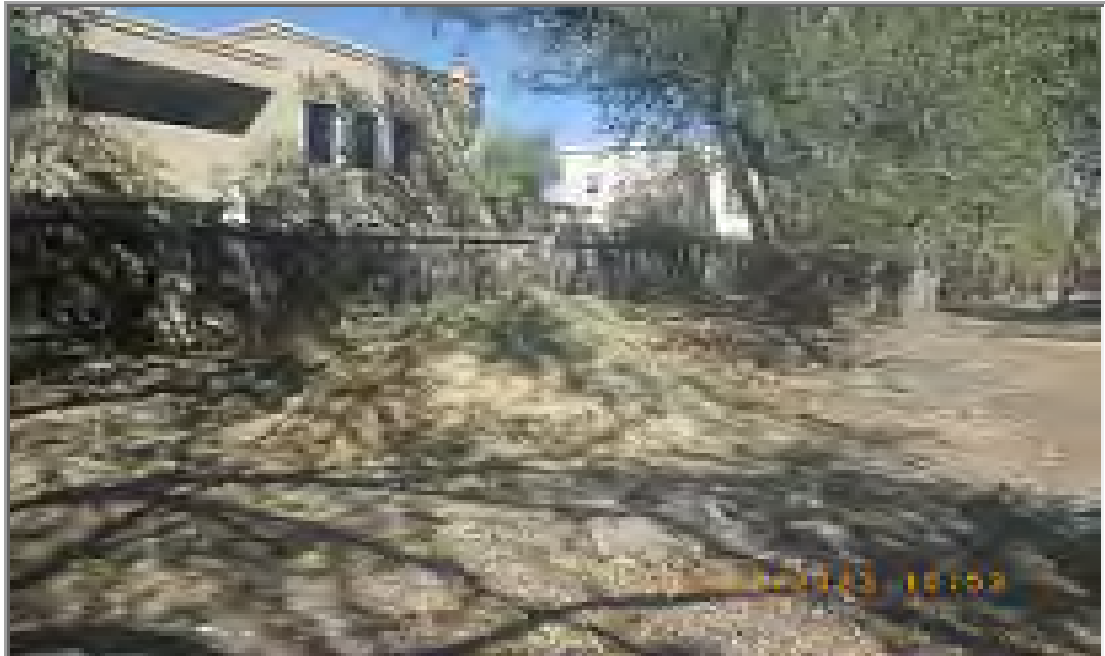
Address

Field Observation THE PILE OF LEAVES AND TREE CLIPPINGS WERE NOT INTENDED AS ANIMAL WASTE COMPOSITE AND NO ODOR NEAR THE PILE. HE HAS 6 GOATS CONFINED WITHIN A FENCE, AND THEIR WASTE IS DUMPED TO CITY TRASH BIN. NO STORMWATER

Initial Action I ASKED HIM TO KEEP THE AREA CLEAN AND GAVE HIM EDUCATIONAL MATERIAL

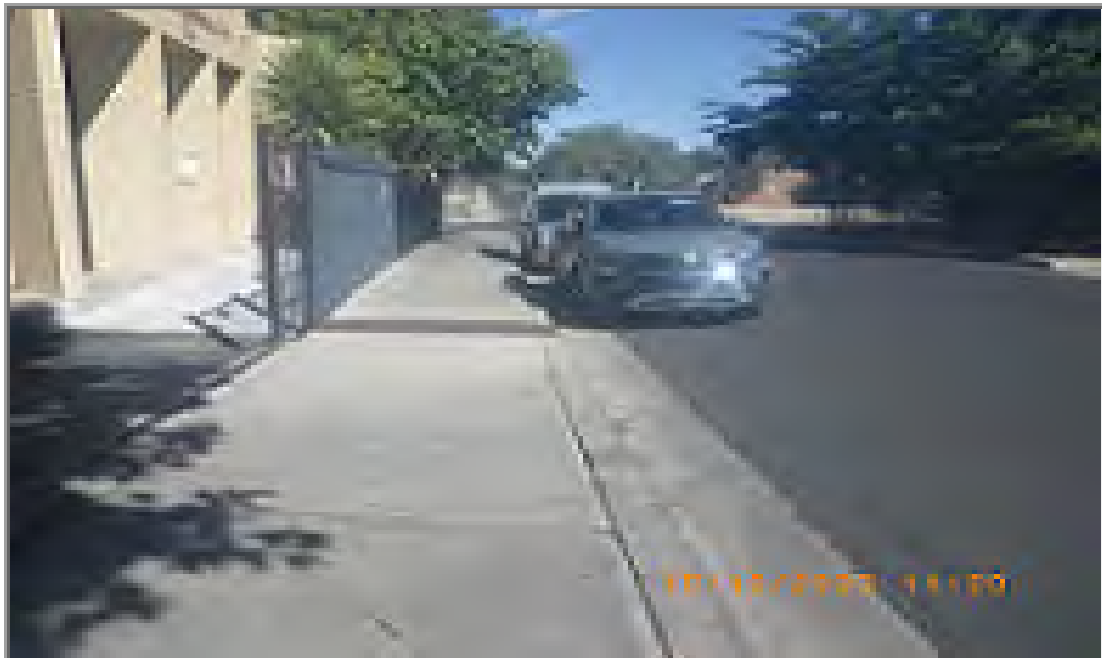
Address **3501 PAN AMERICAN FRWY NE**

Field Observation
THERE WAS SOME DRIED COLORD SPOTS AT THE END OF SIDEWALK CULVERT.

Initial Action
I ASKED THEM NOT TO DISCHARGE ANY POLLUTED WASH WATER TO THE STREET AND GAVE HER SOME POLLUTION PREVENTION BROCHURE.

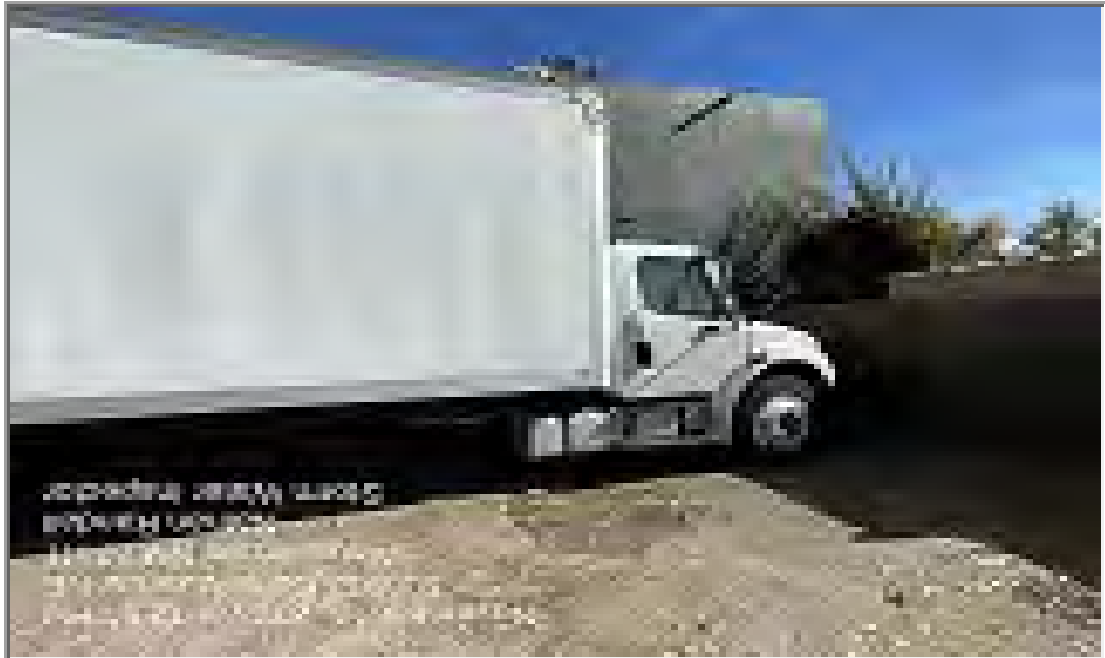
Address **614 FITZGERALD RD NW**

Field Observation IT WAS OIL LEAK FROM THE TRUCK

Initial Action ASKED THE RESIDENT TO CLEAN UP THE OIL SPOTS AND LEFT EDUCATIONAL MATERIAL WITH THE RESIDENT

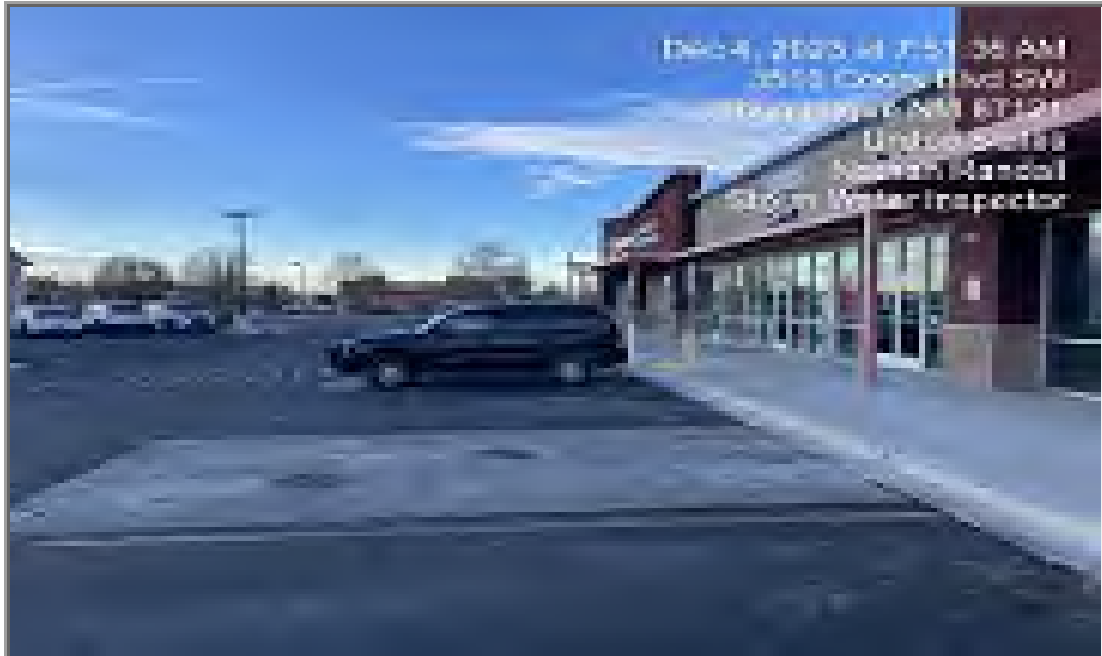
Address **519 MADEIRA SE**

Field Observation THE LEAK WAS FIXED

Initial Action ASKED THE MANAGER TO CLEAN UP THE AREA

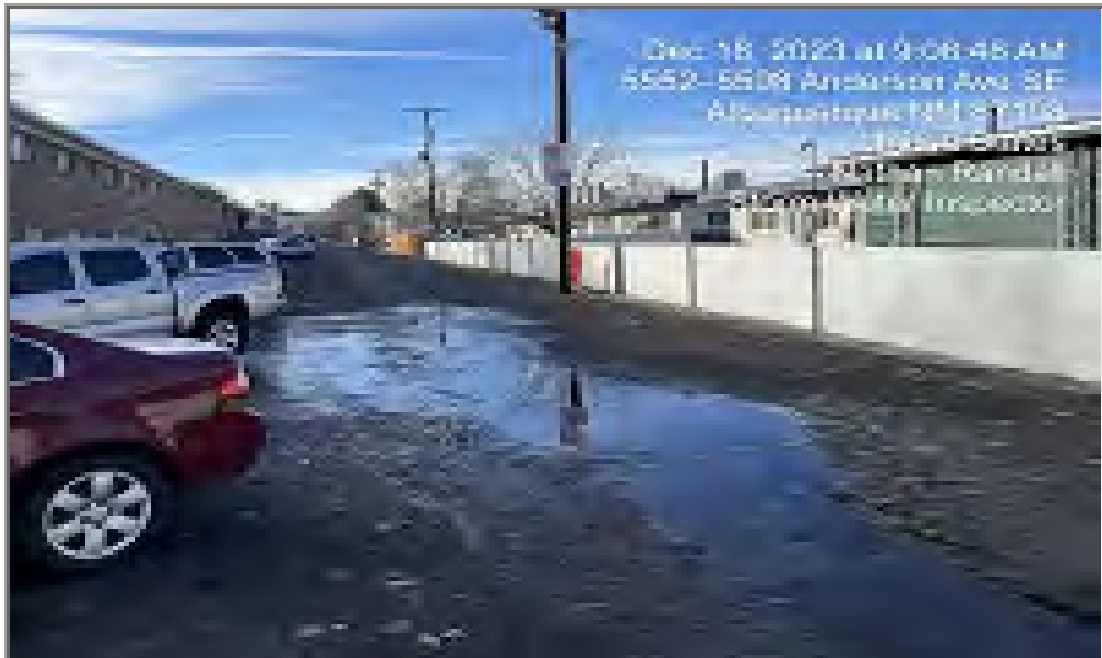
Complaint WE HAD A REPORT OF A LEAK AT THE ABOVE LOCATION

Field Observation SEWAGE WAS COMING OUT FROM CLEAN OUT POINT

Initial Action THE MANAGER DID UNCLOG THE LINE

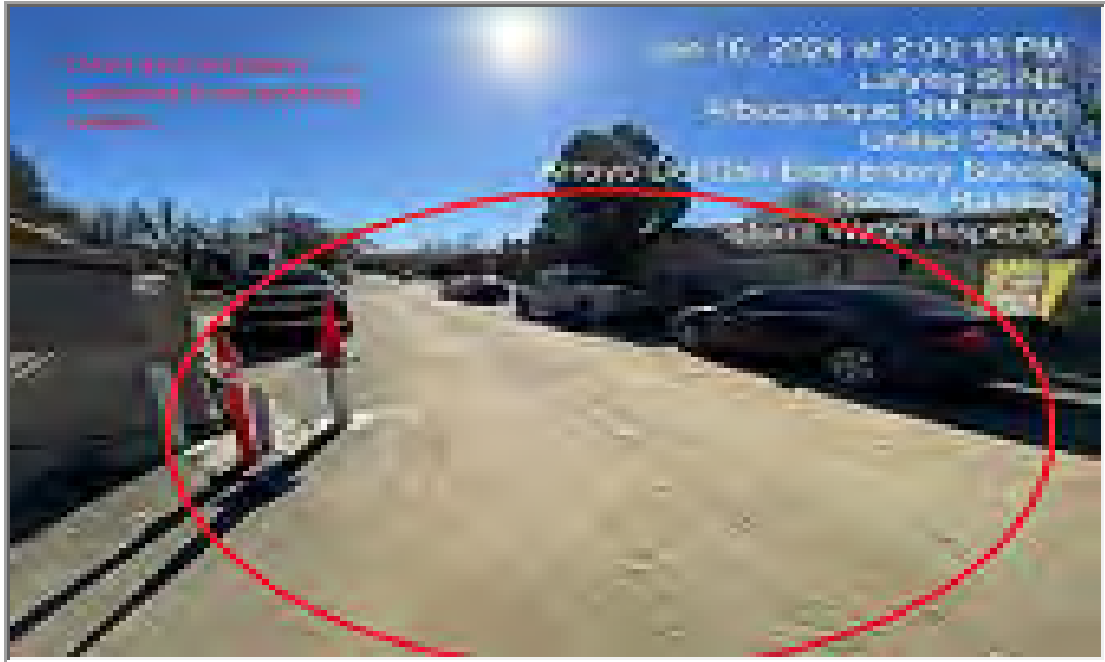
Field Observation THE SOURCE OF MUD WAS FROM A CONSTRUCTION SITE

Initial Action INSPECTOR ASKED THE CONTRACTOR TO CLEAN UP THE AREA AND IMPROVE THEIR BMPS

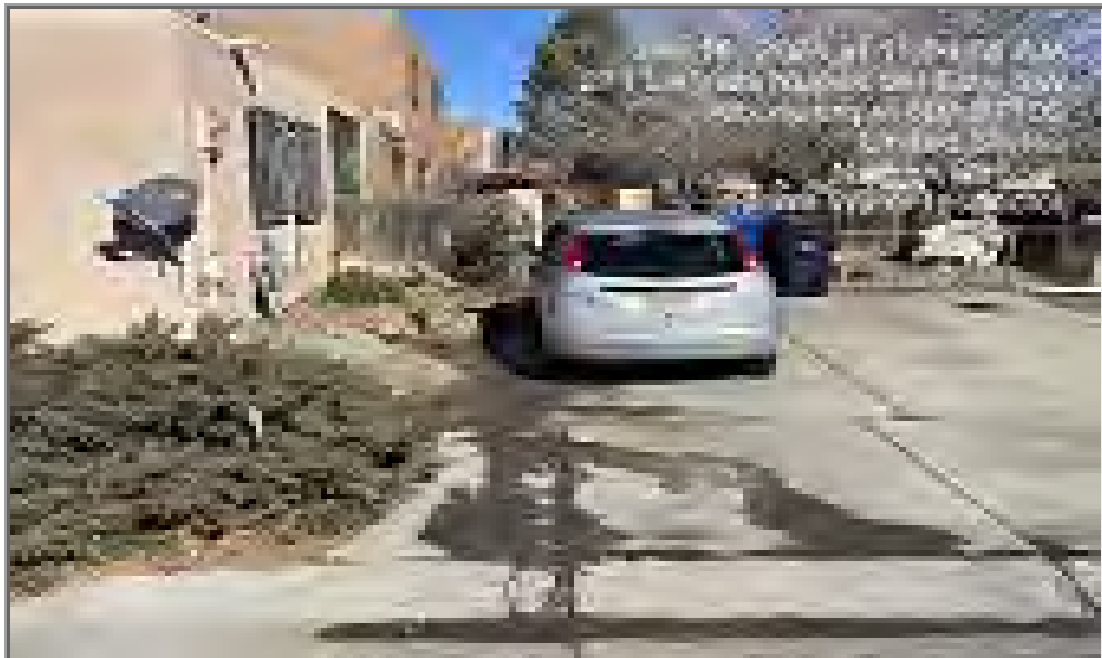
Complaint SEWAGE IS LEAKING OUT OF THE CLEANOUTS IN THE BACK YARD

Field Observation SEWAGE IS LEAKING OUT OF THE CLEANOUTS IN THE BACK YARD

Initial Action THE RESIDENT IS IN PROCESS OF FIXING THE LEAK.

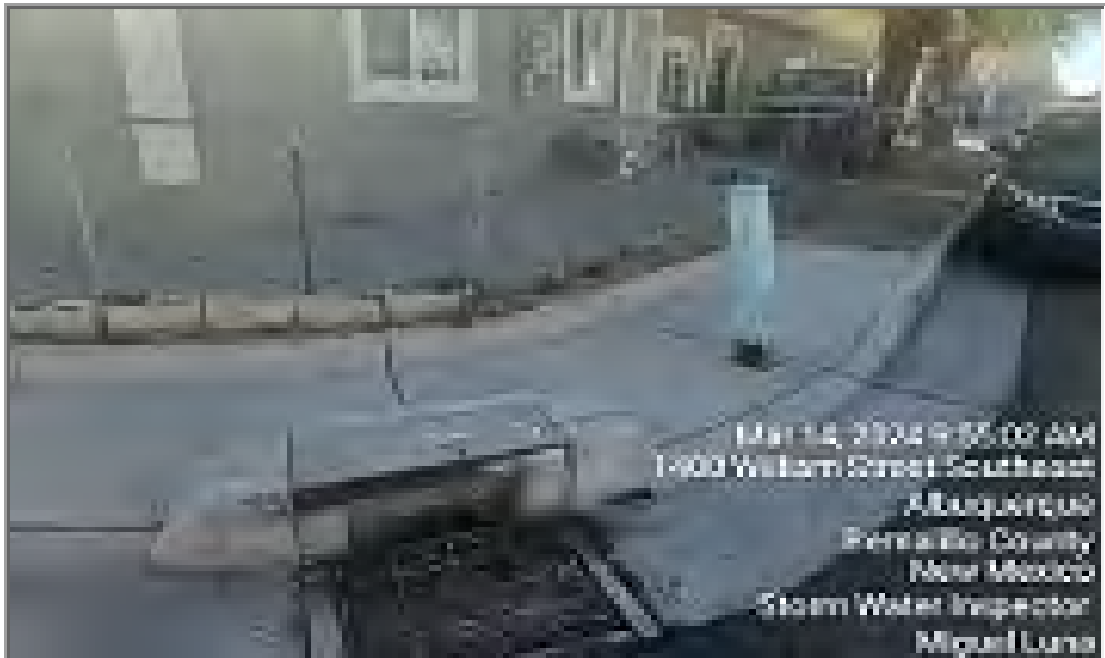
Field Observation THE INLET IN FRONT OF THIS HOUSE WAS DIRTY

Initial Action NO ONE WAS HOME. LEFT EDUCATIONAL MATERIAL AT THIS ADDRESS

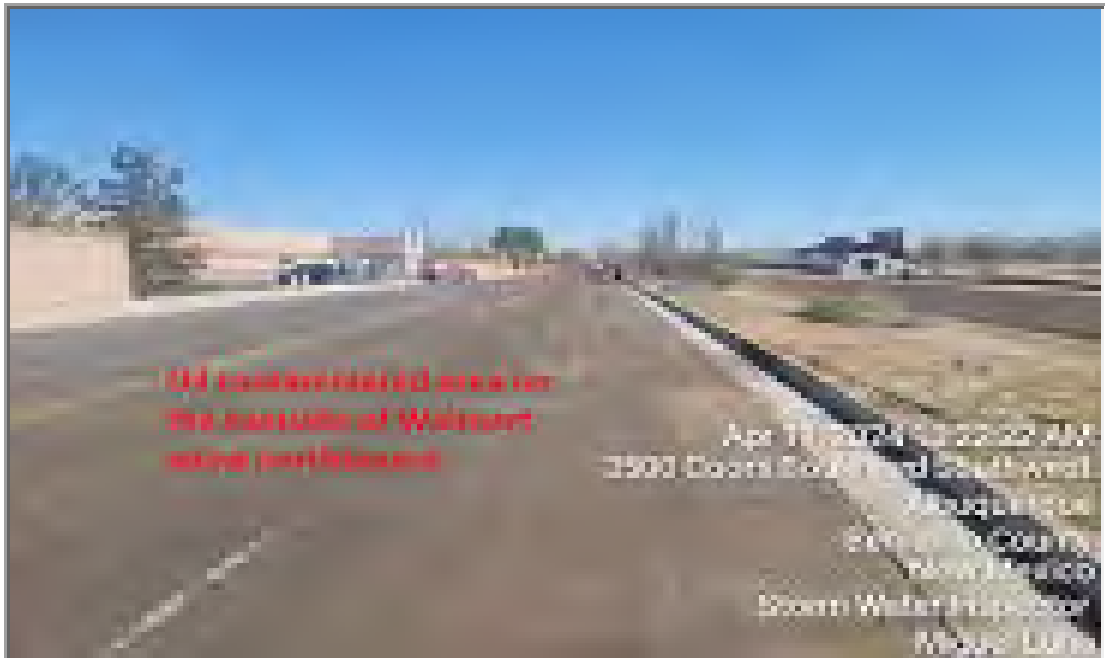
Field Observation THERE WAS LIGHT OIL SPOTS ALONG THE ROAD

Initial Action NO ACTION

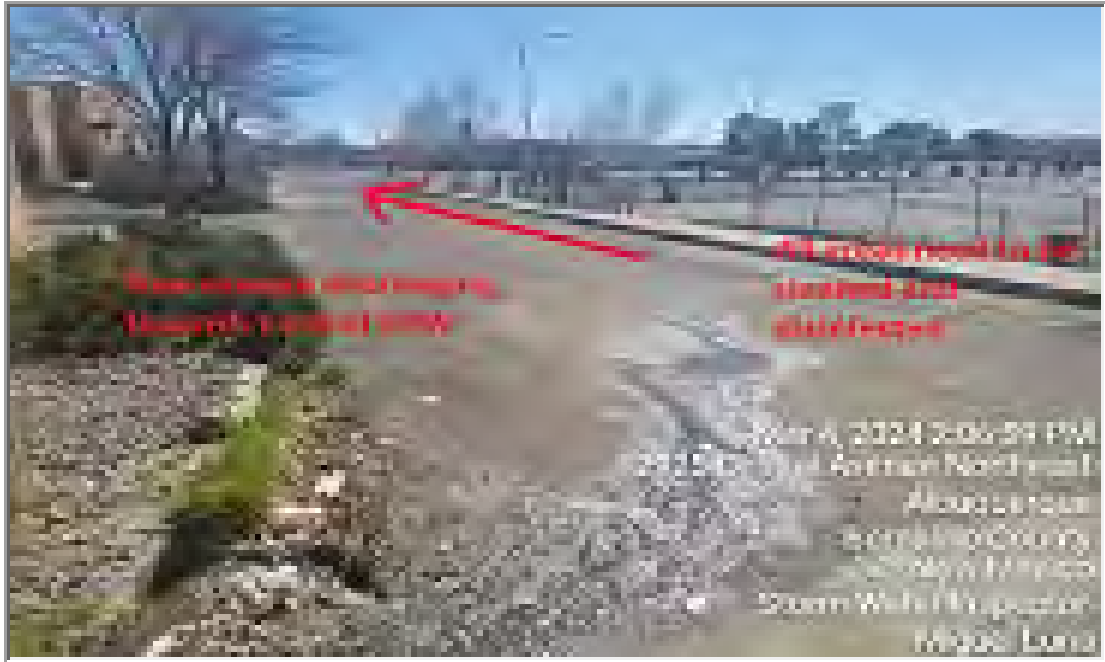
Field Observation RAW SEWAGE WAS FLOWING INTO THE STREET

Initial Action CONTRACTOR DID FIX THE PROBLEM AND CLEAND UP THE AREA

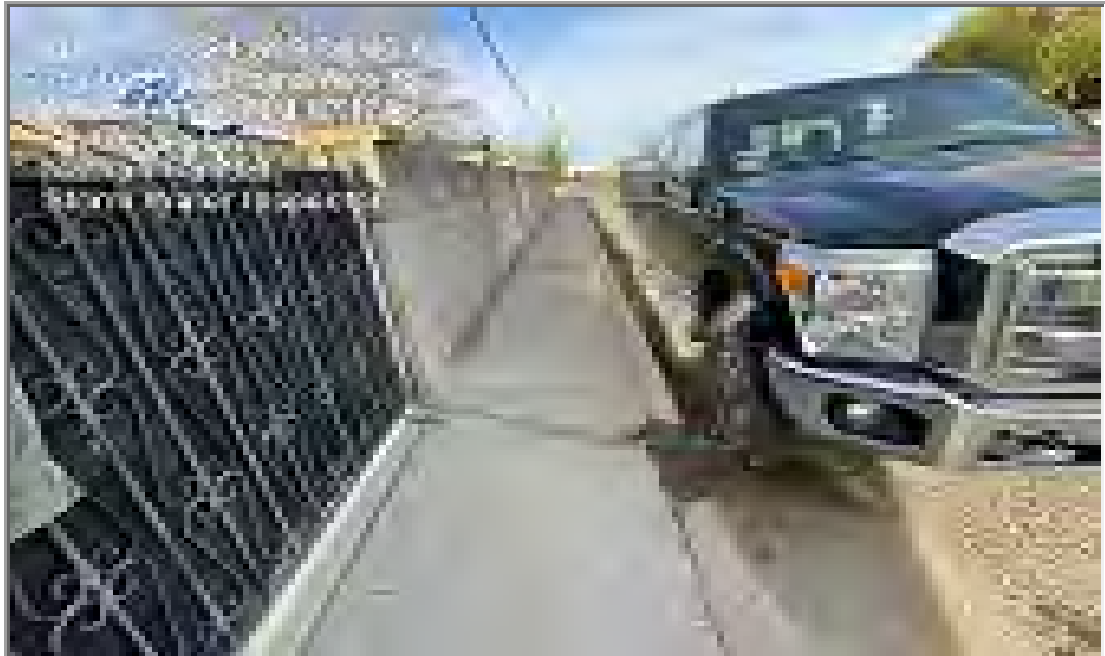
Field Observation THERE WAS WATER ALONG THE GUTTER

Initial Action NOBODY WAS HOME. LEFT EDUCATIONAL MATERIAL AT THIS ADDRESS

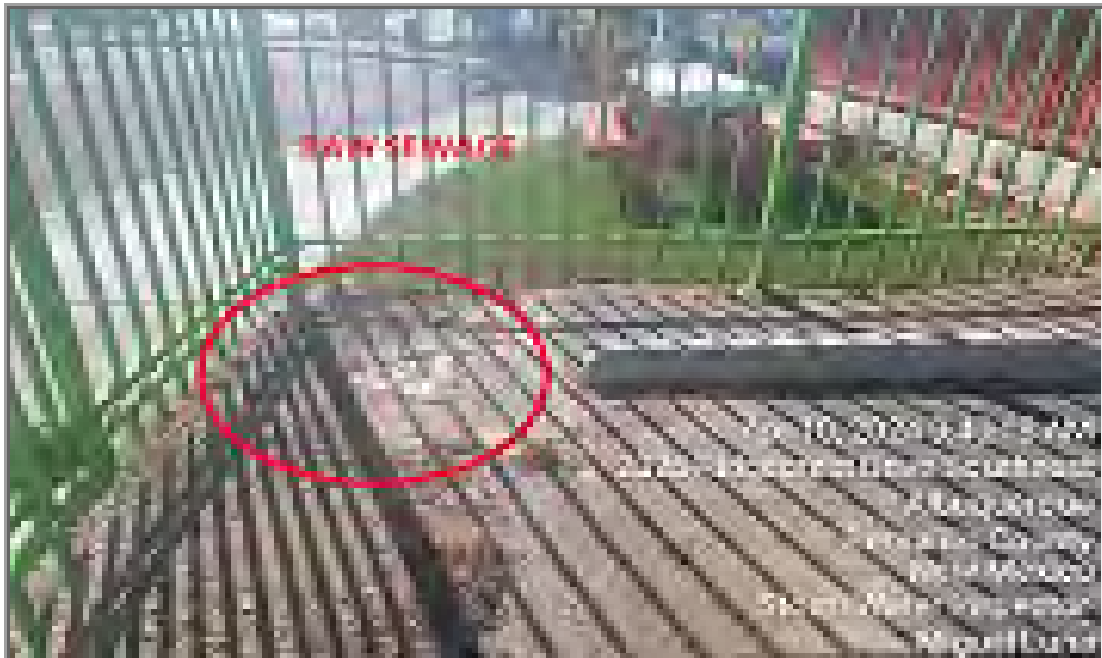
Complaint SEWAGE IS LEAKING INTO THE STREET FROM THE BUSINESS.

Field Observation SEWAGE IS LEAKING INTO THE STREET FROM THE BUSINESS.

THEY DID FIX THE PROBLEM.

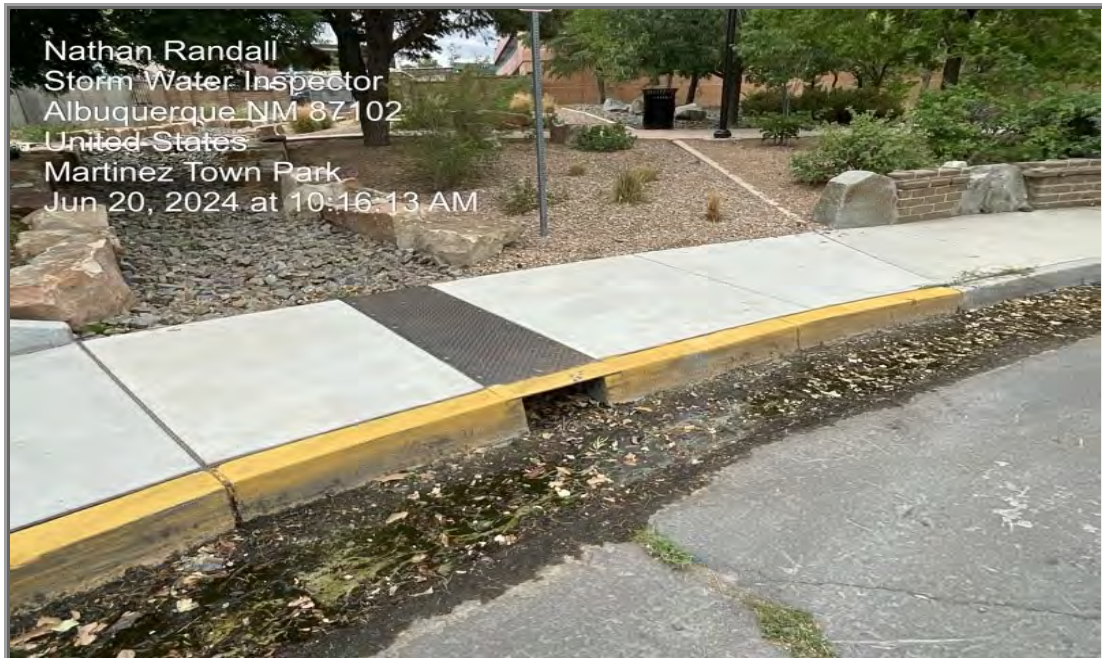
Complaint
IT SMELLS AND LOOKS LIKE SEWAGE I LEAKING OUT AND POOLING ALONG THE SIDEWALK ALL THE WAY TO MARTINEZ TOWN PARK. THIS STANDING WATER AND MUCK HAS BEEN HERE SINCE AT LEAST EARLY MAY.

Field Observation
INSPECTOR VISITED THE SITE AND DOCUMENTED VIOLATIONS

Initial Action
STORM INSPECTOR NOTIFIED THE FACILITES MANAGER, WHO TOOK STEPS TO STOP THE LEAK. DOCUMENTED WITH PICTURES AND VIDEOS.
