SPEED STUDY FOR ARROYO DE VISTA NE

NTMP P80500
Task #4

Speed Study for Arroyo de Vista NE

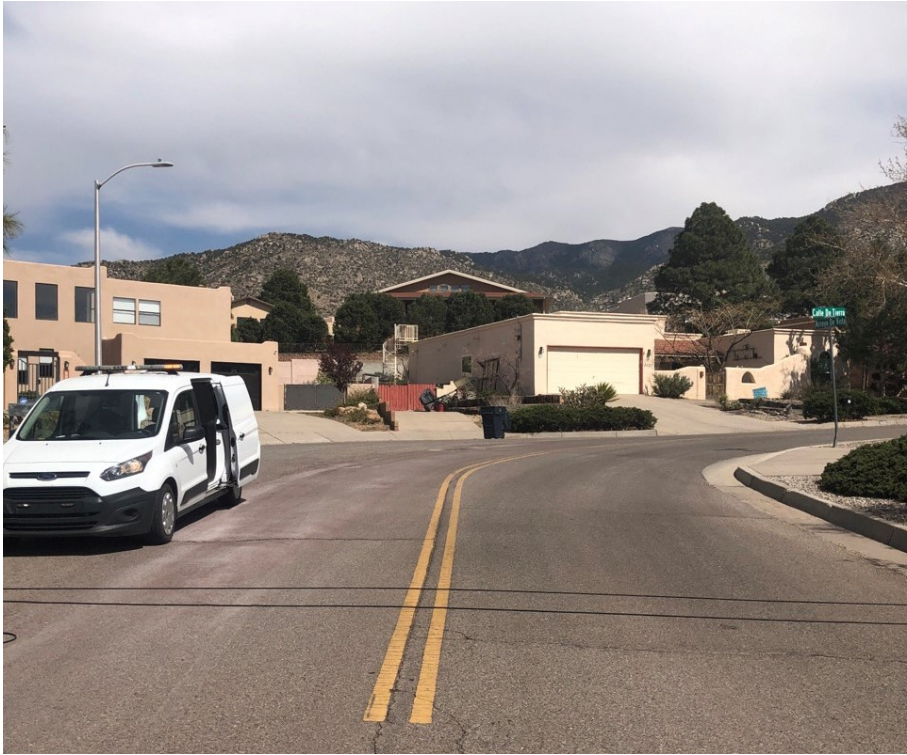
Figure 3: Arroyo de Vista Looking East

The study corridor is an undivided urban local street. The street is free of any road surface markings to delineate traffic lanes or indicate the presence of bicycle lanes. Figures 3 and 4 show the street's current conditions.
