The Secretary
of the Interior's
Standards for
Rehabilitation &

Illustrated
Guidelines
for
Rehabilitating
Historic
Buildings

U.S. Department of the Interior
National Park Service
Cultural Resources
Heritage Preservation Services

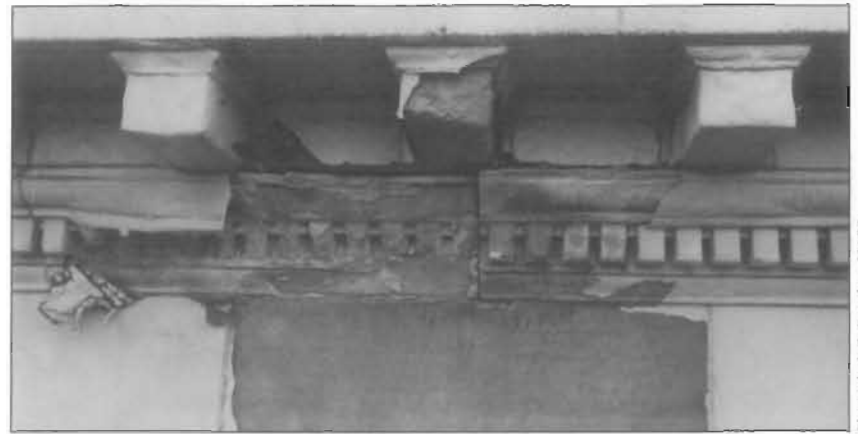
Excessive moisture has damaged not only the stuccoed wall surface, but also the brick substrate.

Moisture from a faulty roof and drainage system has been trapped inside this limestone cornice by a waterproof coating, causing severe damage to the stone.

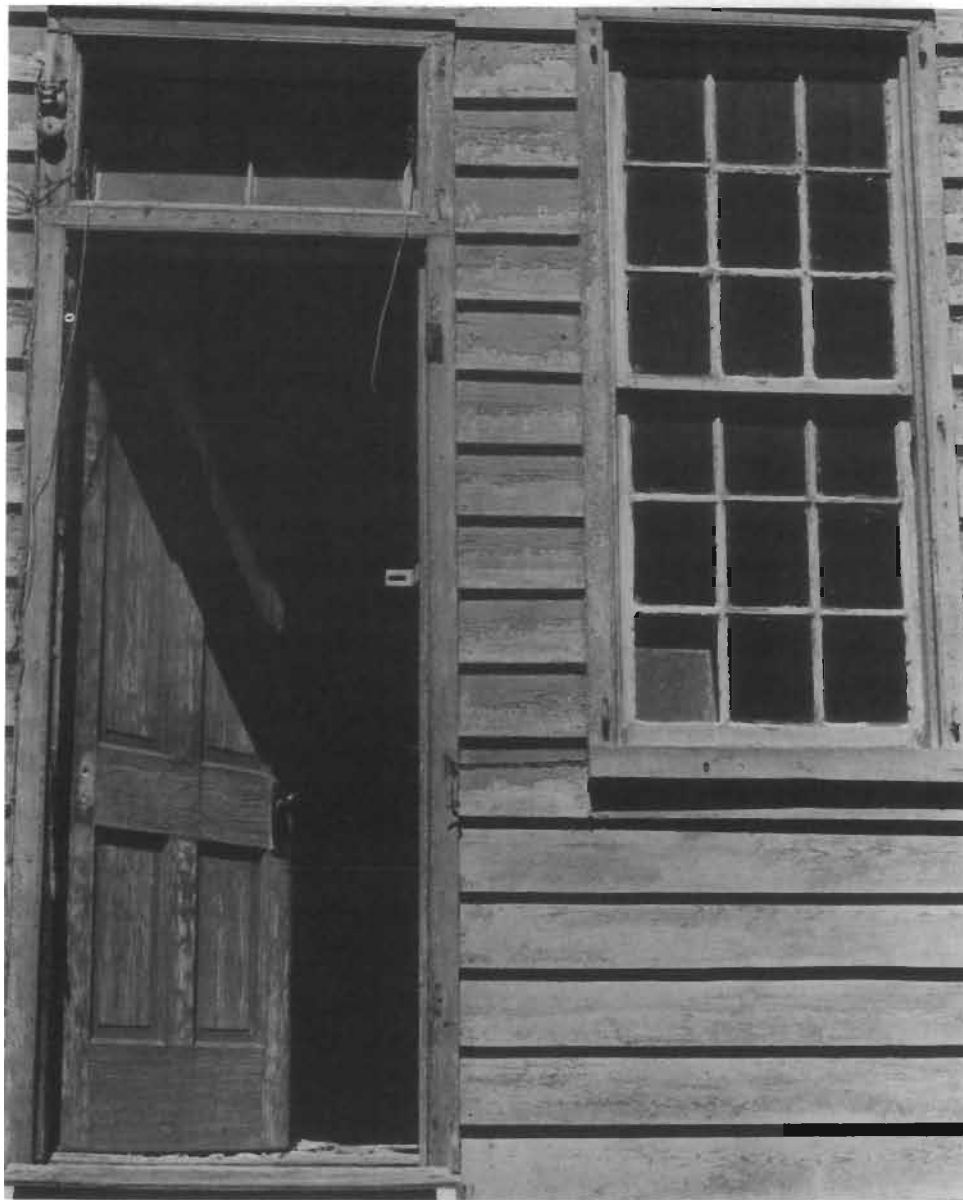
To replace deteriorated portions of the column, strips of new wood were milled to conform to the shape and appearance of the old column framework, glued in place, then back-primed and painted.

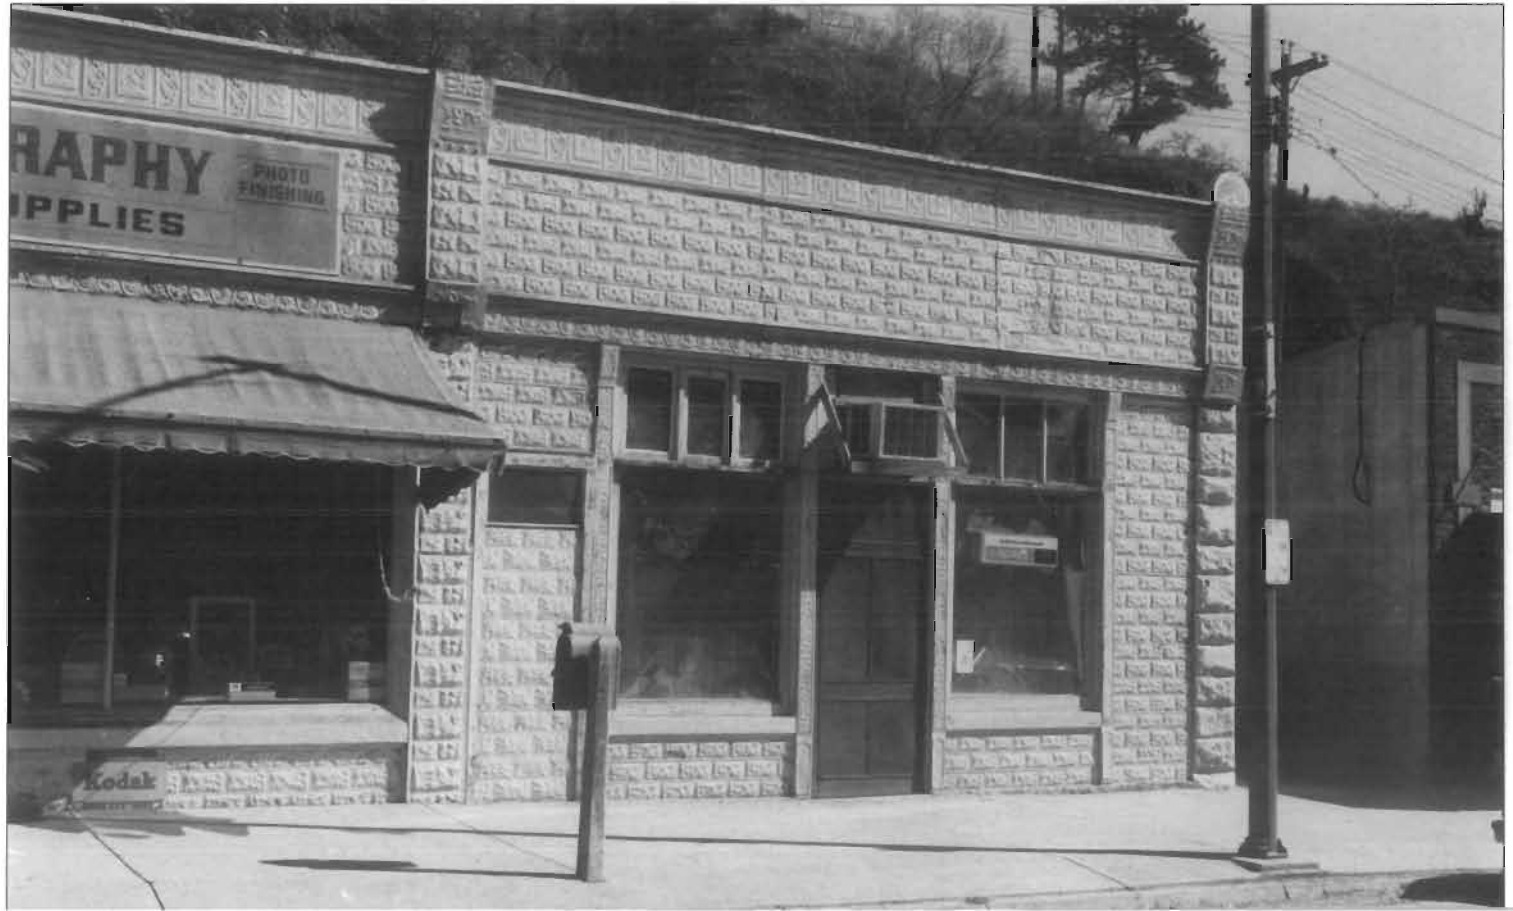
Although these pressed metal storefronts have been well maintained over the years, gaps in the seams between the metal sheets above the door and slight stains along the cornice line indicate a possible roof leak. The roof should be investigated and repaired before the moisture results in rust and more severe metal deterioration.

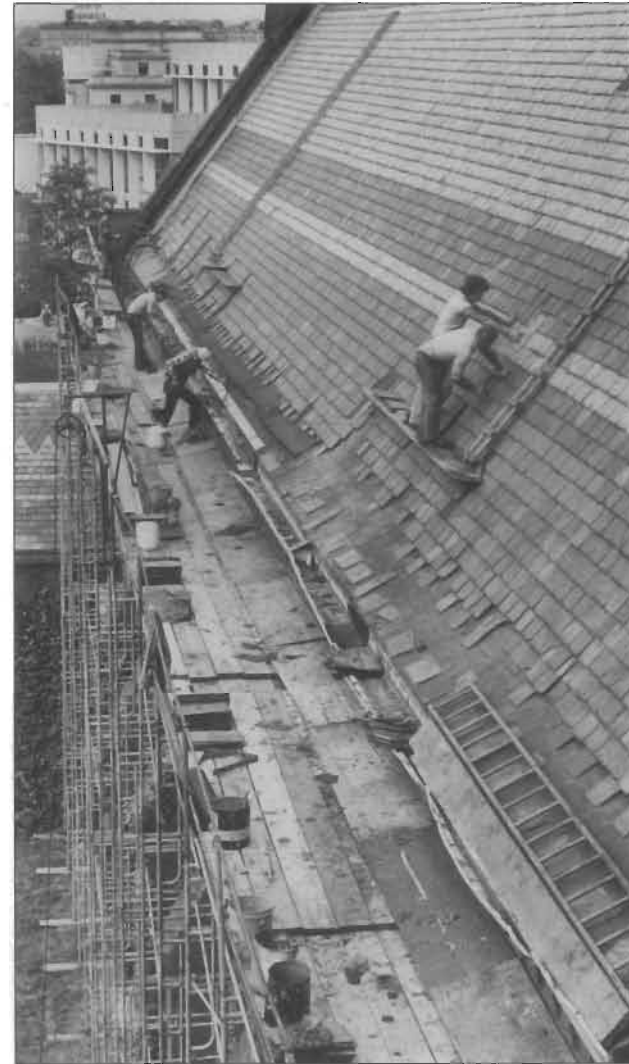
Workmen are in the process of removing deteriorated roofing slates and replacing them with new matching slates.

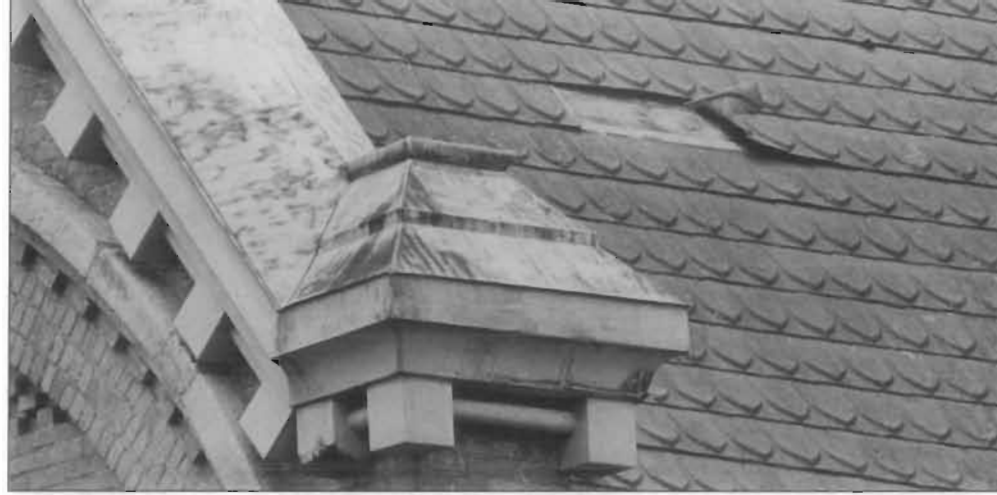
New galvanized sheet-iron shingles will need to be reproduced using the pattern of the original shingle.

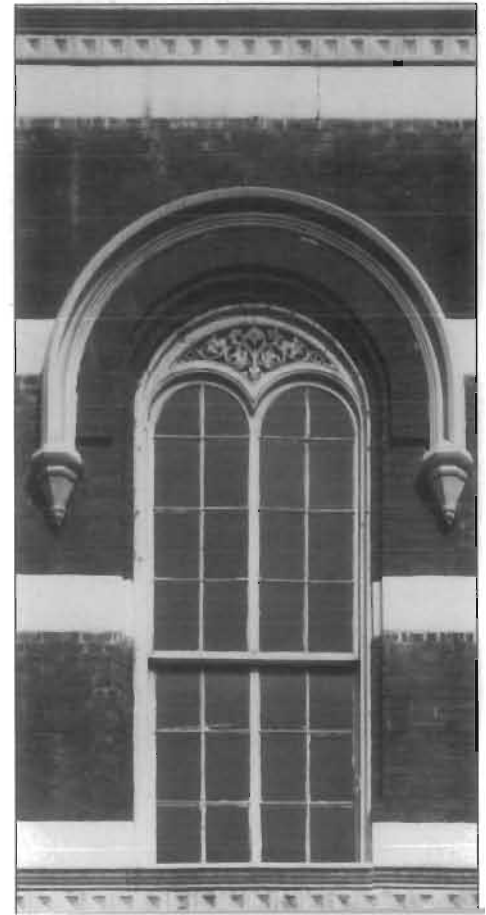
Deterioration of poorly maintained windows usually begins on horizontal surfaces where water collects. Problem areas on this sill are clearly indicated by paint failure due to moisture.

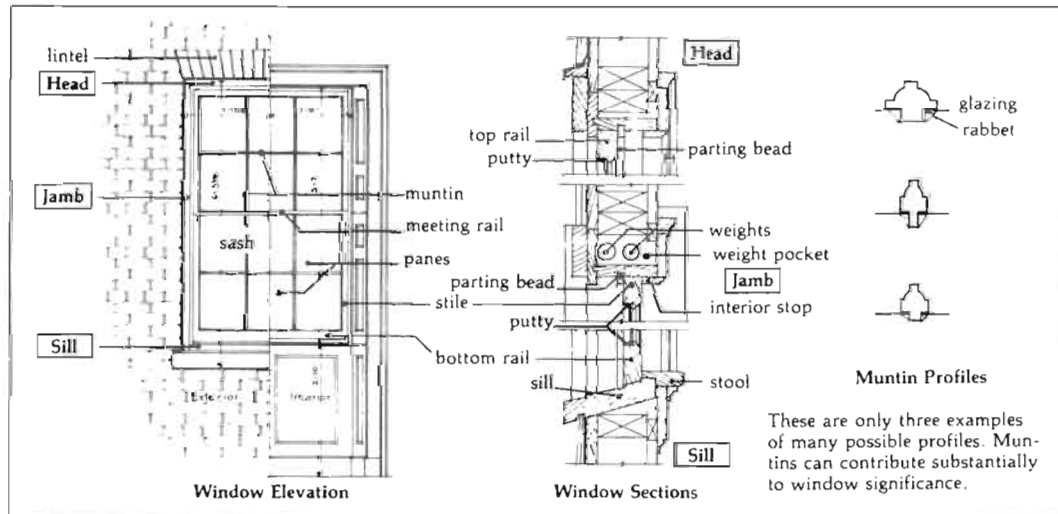
These drawings identify individual parts and fabrication details of a historic wooden double-hung window.

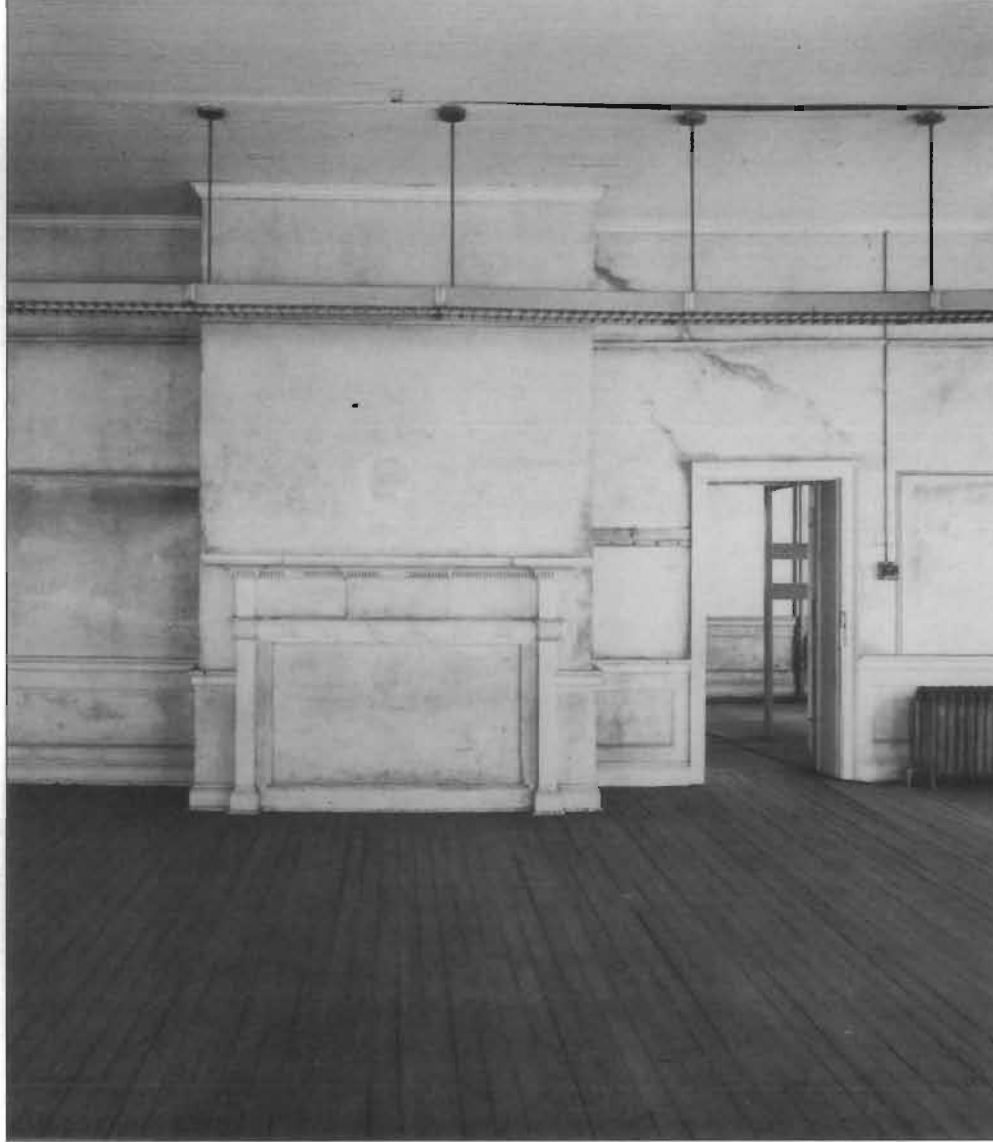
This row of hanging fluorescent lights installed in an earlier renovation mars an otherwise classically detailed interior. They have also caused the historic beaded ceiling to pull away from the joists.

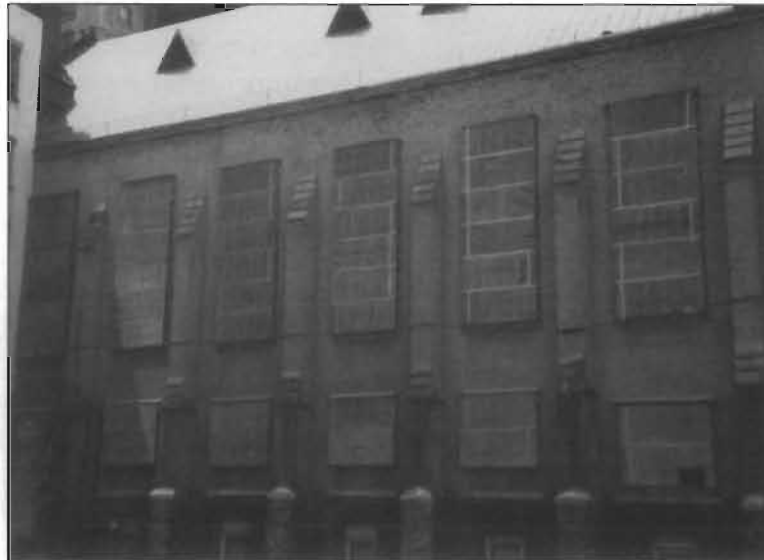
▲► The roof and stained glass windows of this historic church have been appropriately covered with plywood as a protective measure during construction of a new building on an adjacent lot.

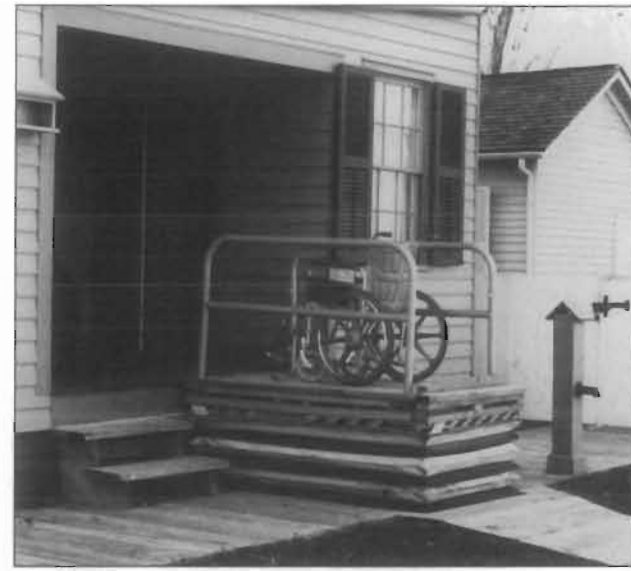
An accordion-type platform lift that retracts to ground level when not in use has been installed to make this historic house accessible.
