INTERSECTION ASSESSMENT

98TH STREET SW/BENAVIDES ROAD SW
ALBUQUERQUE, NEW MEXICO

Department of Municipal Development
Project No. 7703.25
Task 17

April 15, 2019

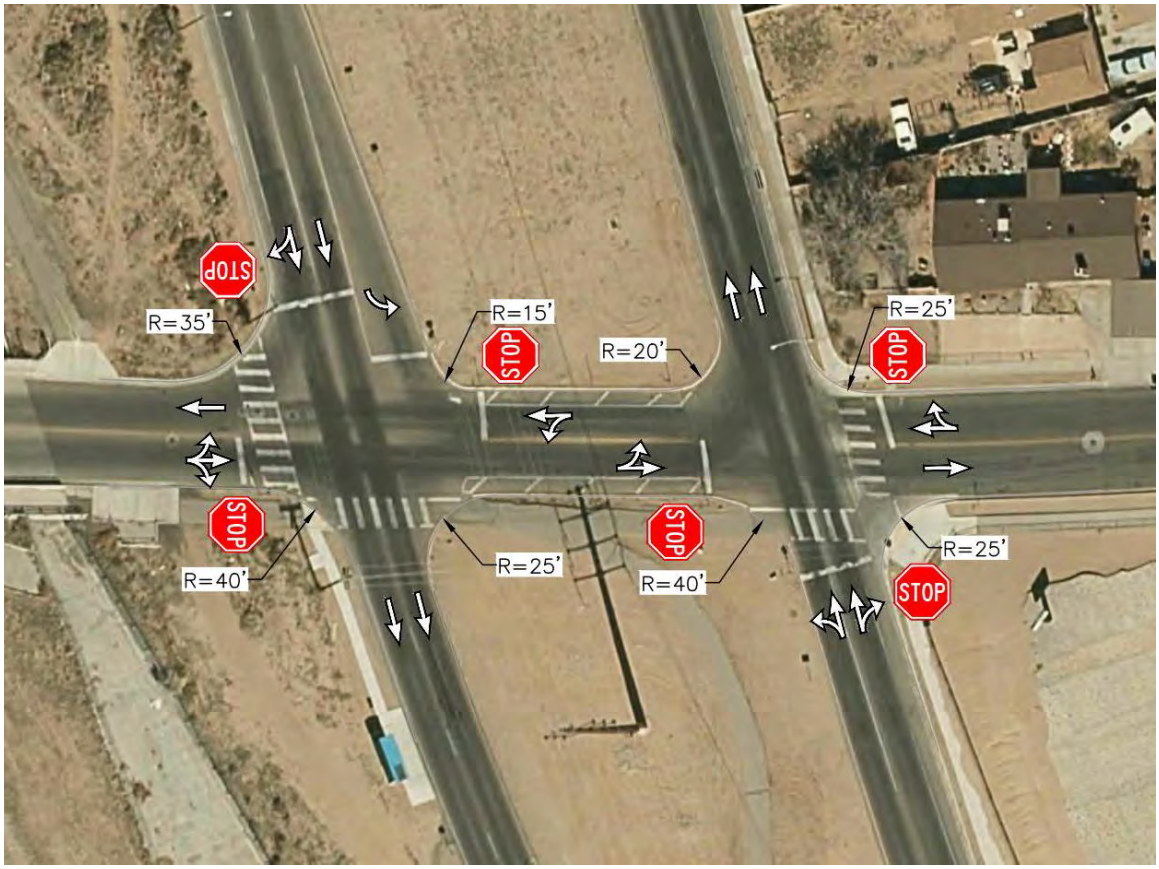
Figure 3 – Intersection Control and Curb Return Radii

As shown in **Figure 3**, the existing curb returns at the intersection range from 15-feet to 40-feet. On the north side of the intersection, there are two curb returns that do not meet the DPM criteria however vehicles do not turn directly through these returns; with no off-tracking expected, the deficient curb returns on the north side of the intersection do not warrant reconstruction. On the south side of the intersection there are two curb returns that are deficient, however there is benefit to the smaller curb return radii with respect to crossing distance. Reduction of the curb return to benefit pedestrian crossing distance considerations should be given to the returns with 40-foot radii on the south side of the intersection

When the radius is too small, longer vehicles will likely encroach either onto the curb and beyond or into the opposing lane. The existing intersection has a heavy vehicle percentage of 2.6%. Based upon site observation and traffic counts, it is not uncommon for heavy vehicles (WB-40 – WB-67) to negotiate the intersection.

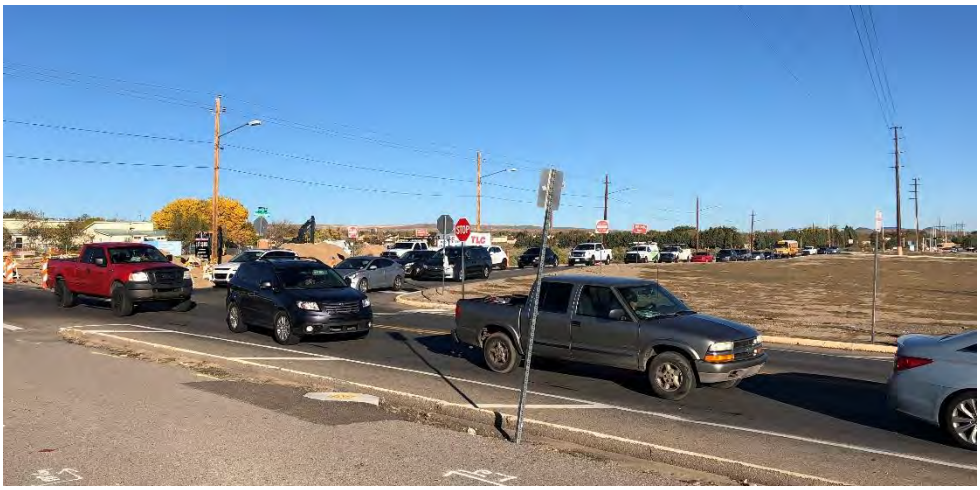
Photo 6- Observed Southbound Queues

The analysis found adequate storage capacity at the intersection. One potential issues are queues from the Truman Middle School pick up/drop off driveways impacting the ability of vehicles to move eastbound. This condition results in vehicular conflicts, perhaps in the form on rear-end collisions and increased delay for vehicles trying to travel eastbound. Based on a site visit in November 2018, queues up to 600-feet northbound were observed.

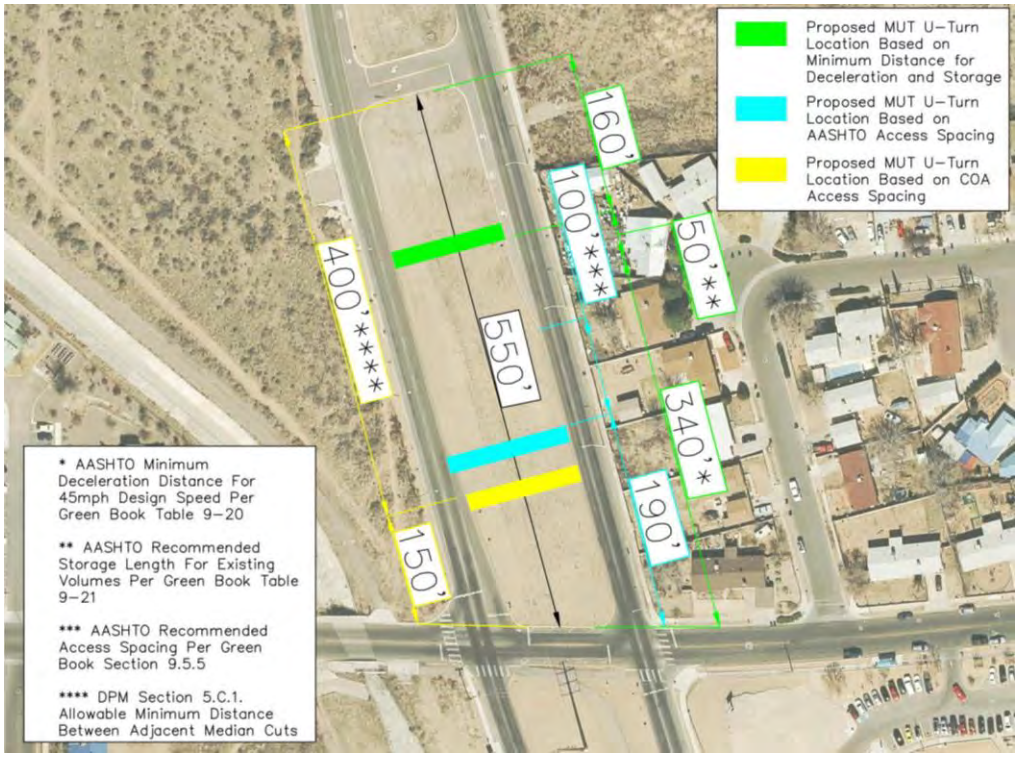
Figure 21 – Existing Median Access Spacing

As stated in the DPM (*Chapter 23, Section 5, C.,1*), the allowable minimum distance between the ends of adjacent median cuts on arterials is 400-feet (**Appendix B**). As shown in **Figure 21**, placement of the median U-turn in accordance with the DPM would result in 150-feet of available space for deceleration and storage. The AASHTO Green Book guidance for Indirect Left Treatment configurations, Section 6.5.5, recommends the placement of U-turn at least 100-feet in advance of the next downstream left-turn lane. As shown in **Figure 21**, placement of the median U-turn in accordance with the Green Book access spacing recommendations would result in 160-feet available for deceleration and storage.

Based on the available median width at the 98th Street/Benavides Road intersection, Indirect Left Treatment could be built, however, the spacing between the existing north median access point (opposite R-T zoned property as shown above) and the new median U-turn will not meet DPM access spacing requirements.
