# EL VADO, MOTEL

## Structural Evaluation

Final Report August 2006

Prepared by:  
**Druc Engineering**  
1300 Luisa Street, Suite 23  
Santa Fe, New Mexico 87505

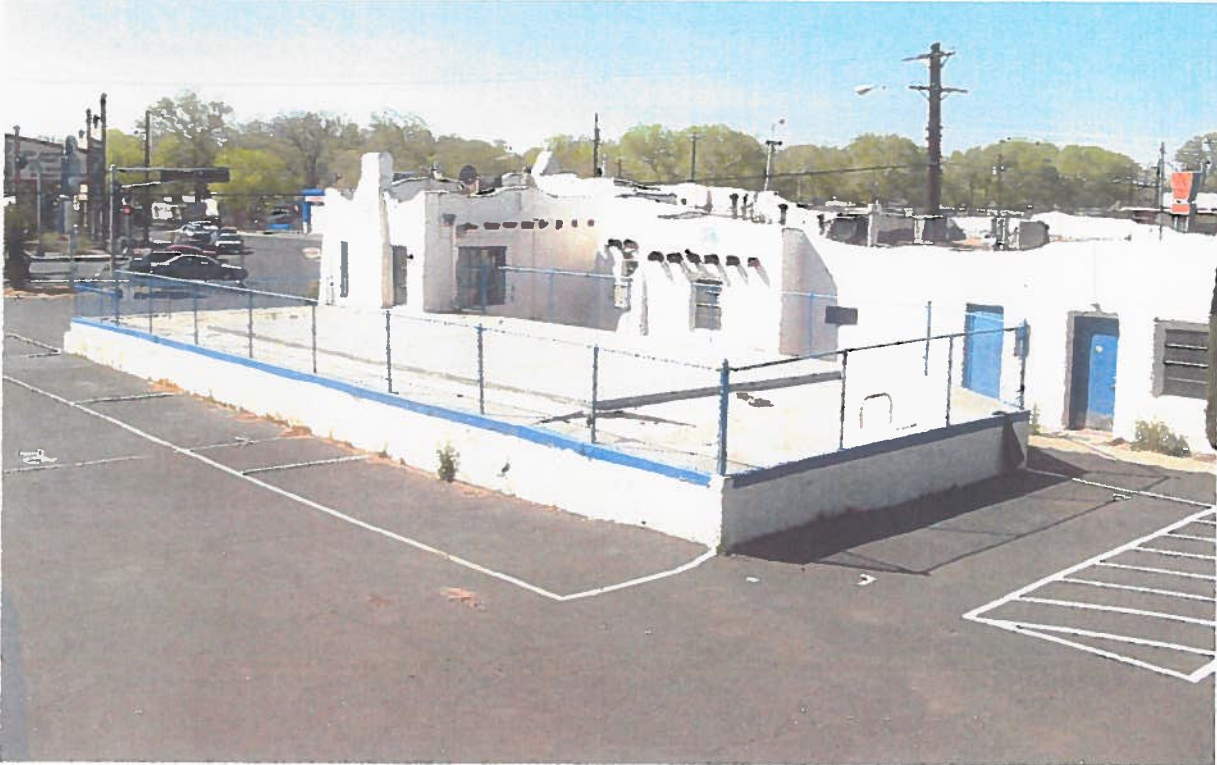
**Figure 12 El Vado Swimming Pool**

The swimming pool of the El Vado has been closed for a few years due to structural cracks in the concrete walls and decking (Figure 13). Currently the perimeter is enclosed with a chain link fence. The pool surface is covered with plywood panels and asphalt roofing. The mechanical room for the pool is also dilapidated and is out of compliance with plumbing and electrical codes.

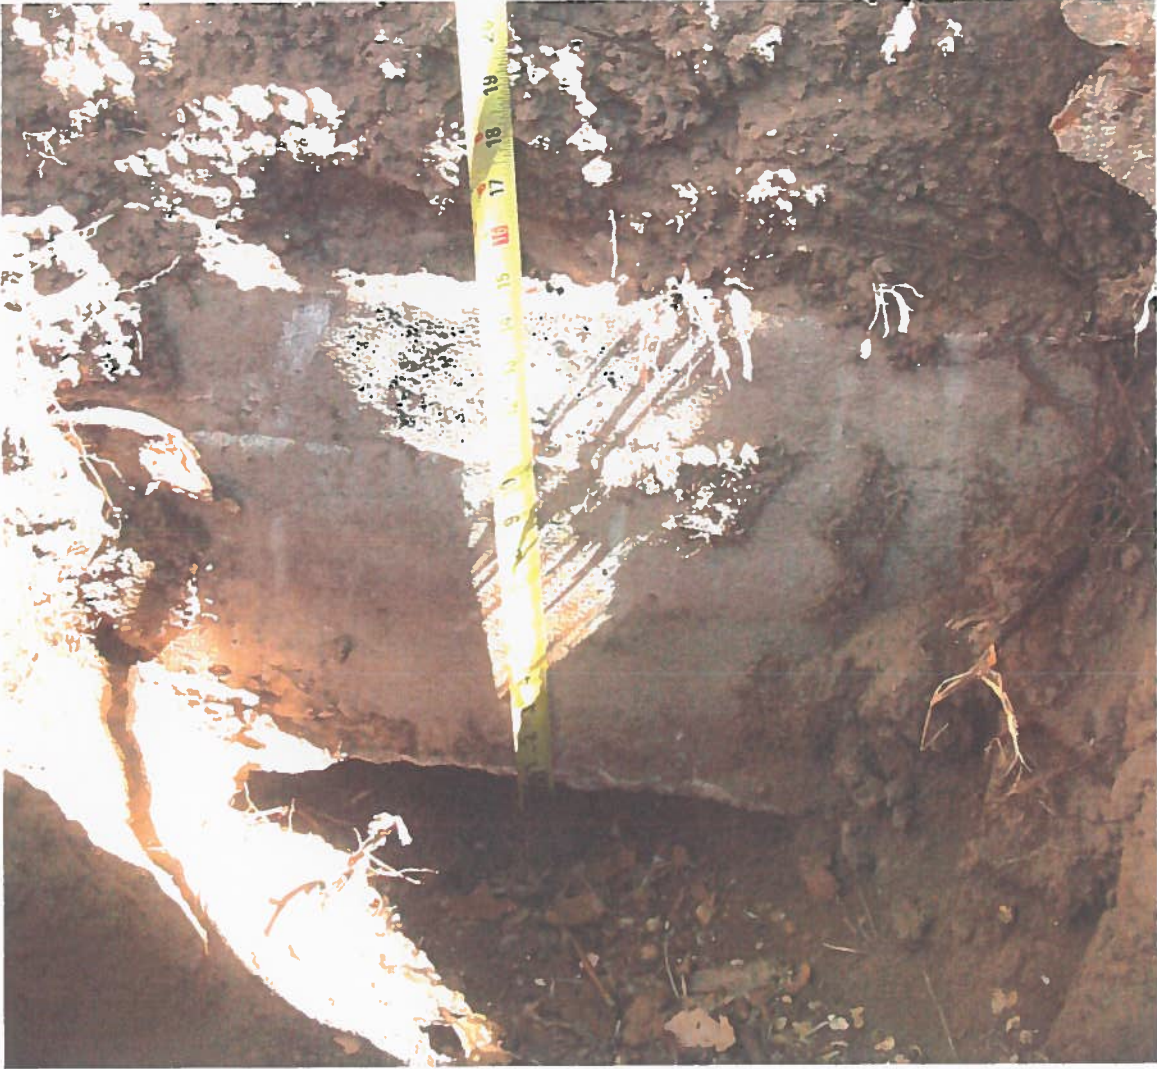
**Figure 18 - Field Verified Foundation Detail - Building**

The foundation system consists of cast in place concrete monolithic slab/footings approximately 14-inches depth by 12-inches wide. The concrete slab is 4 to 6 inches thick.

The onsite investigation hand dug a trench to expose the existing foundation. We discovered a foundation system consisting of a monolithic turn down slab (*See Figure 16*). *Our investigation found that the footing width is adequate but the depth of the footing to the frost line is inadequate.* The footings are in fair condition, however, there are signs of building settlement at various footing sections. The stem walls are not waterproofed. The investigation did not discover any foundation drains.

- 1. The soils adjacent to the footing need to be lowered so that all adobes are above finish grade. Offsite drainage to the south needs to be mitigated.**
- 2. The footing wall needs to be waterproofed and insulated by an approved method. A foundation drain should be installed adjacent to the footing. An approved design should include a drain pipe, with an appropriate geotextile to prevent clogging, and appropriate placed gravel to direct moisture into the drain. The drain should run down at an appropriate slope out to daylight.**
- 3. Downspouts and gutters need to be cleaned, prepared and sealed.**
- 4. Leaders should be installed to divert water away from the building foundation.**
- 5. The roof needs to be reconstructed to provide appropriate overhangs, parapets and flashing.**

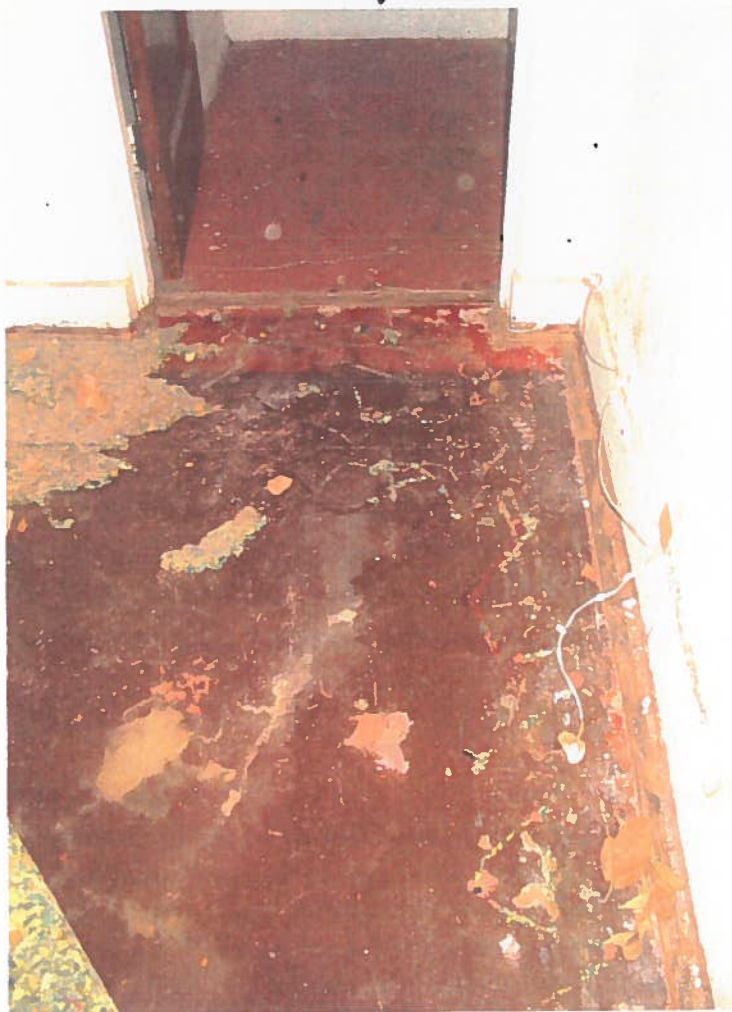
**Figure 20 Cast in Place Concrete Floor Slab**

The investigation revealed concrete slab floors throughout the El Vado facility. The floor slabs appear to be poured in conjunction with a foundation wall forming a typical monolithic slab turn down footing.

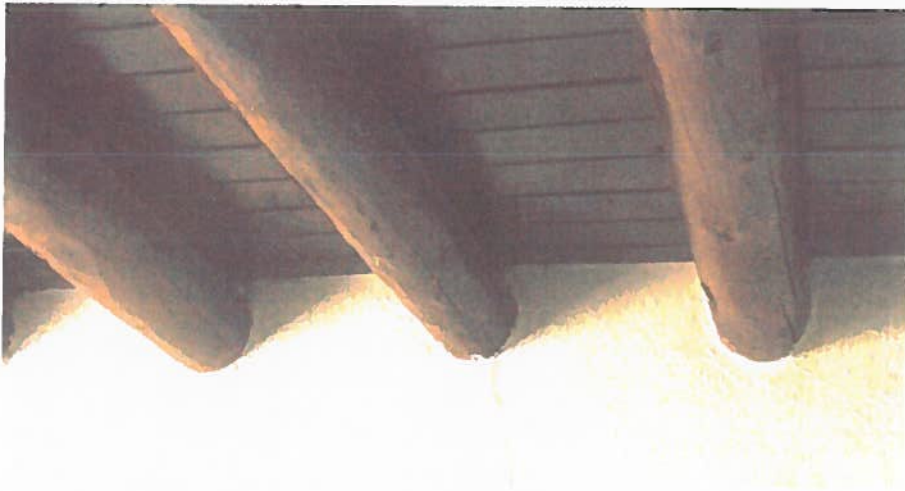
**Figure 21 Typical Viga Layout**

The main structural framing members for all the roofs of the El Vado are the structural wood vigas. The vigas have diameters ranging from 6-inches to 8-inches at their ends. *Some vigas have serious problems with dry rot at the exposed ends where they are supported on load bearing walls.* The structure of the motel's roofs is composed of a roof ceiling assembly (vigas spanned by 3/4 of an inch thick tongue and groove wood decked ceiling with no insulation above) then layers of roofing material.

- 1. Inspect and evaluate each viga end throughout the buildings to check for rot and repair as necessary.**
- 2. Inspect and evaluate each viga for stress cracks, excessive deflection and repair as necessary.**
- 3. Inspect and evaluate roof sheathing. Replace with 3/4 inch sheathing as necessary.**
- 4. Insulate roofs to code standards and replace entire roof surfaces.**
- 5. Overhangs, gutters etc.**

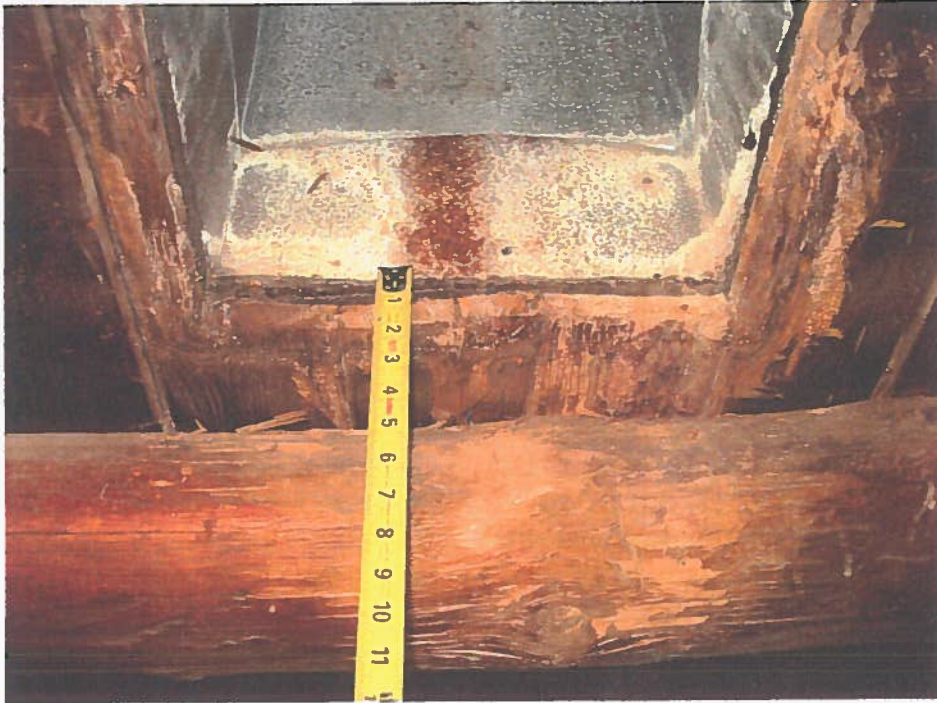
**Figure 23 Roof Sheathing and Layered Roofing Sheets**

The roofing surface is in poor condition with several patched spots throughout causing water pooling and subsequent damaged. Due to the large number of roof penetrations from the utility lines there are numerous leaks throughout all roof surfaces. It seems that repairs were made to the roofing at numerous times. We noticed soft spots on the roof indicating possible failure of the roof sheathing. Some minor deflection was observed throughout portions of the roof.

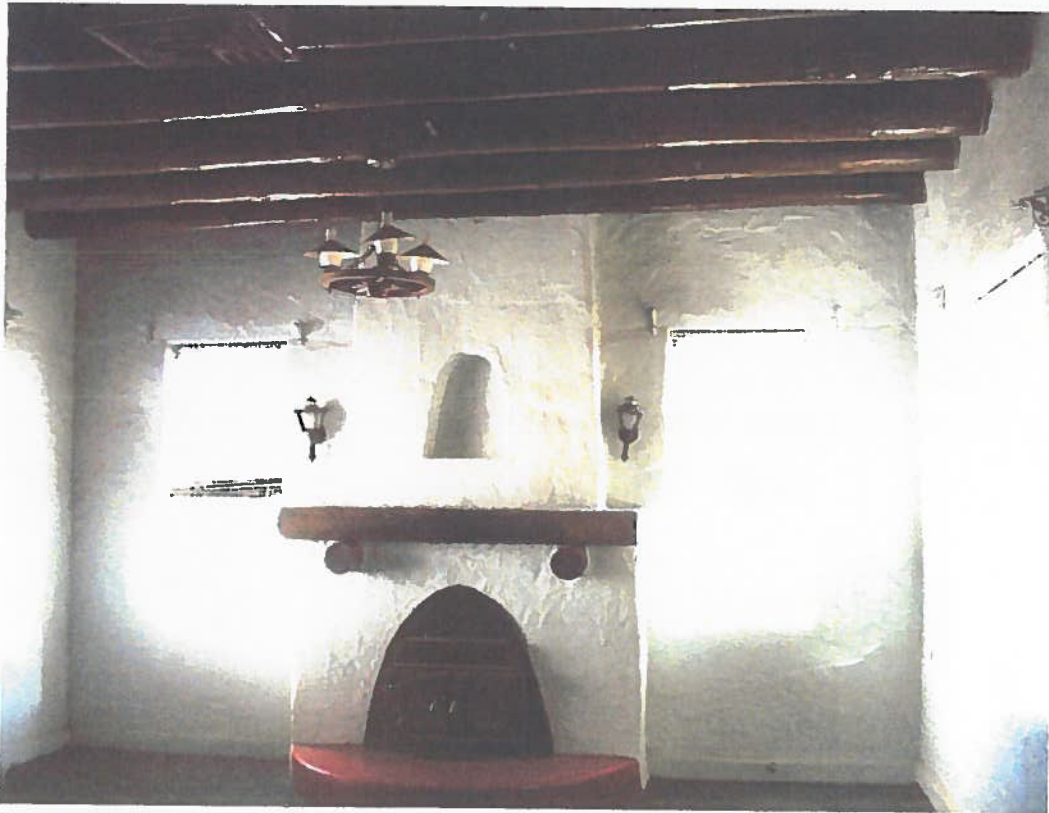
**Figure 25 Roof Vigas at Office/Lobby**

The lobby/office building of the El Vado's roof structure is composed of wood beams spaced at approximately 24 inches from centers. The low pitched roof is covered with lapped asphalt membrane roofing. This roof appears to be in poor condition. This roof contains numerous vent stacks, swamp cooler and ventilating equipment. The exposed viga ends that extend beyond the walls are in a deteriorating condition due to dry rot.

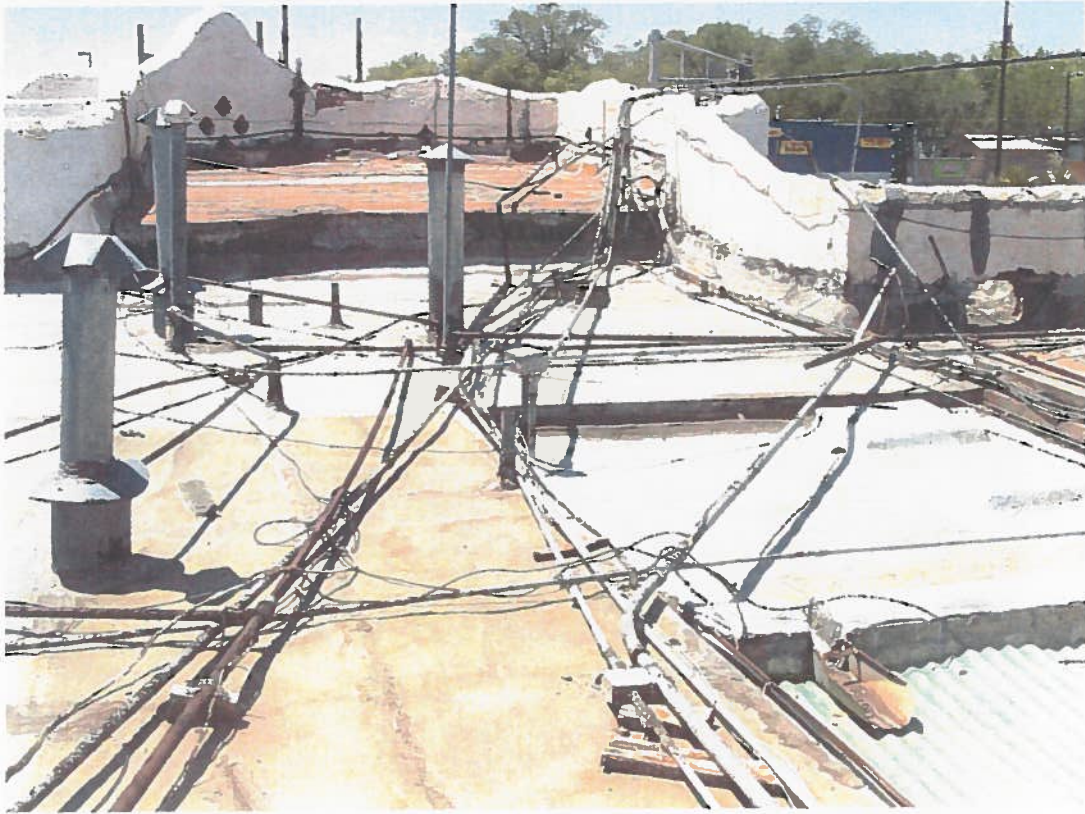
Generally, such penetrations to roofing membranes at the El Vado facility have created roof and ceiling leaks.

**Figure 26 Office/Lobby Roof Pipes & Electrical Lines**

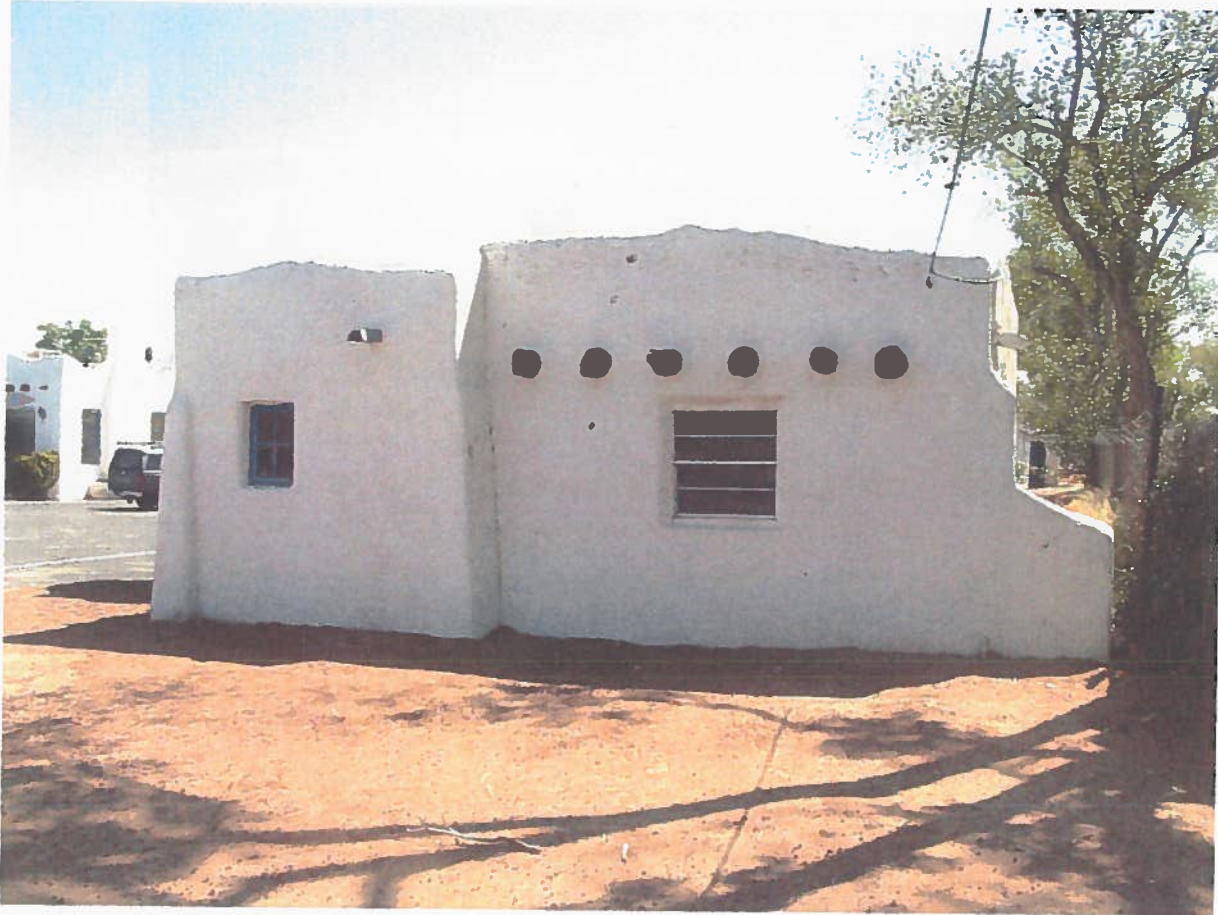
The southwest building (Building 3, Figure 9) has 8-inch thick walls consisting of hollow clay tile 4-inches thick by 8-inches long. The interior load bearing walls are also constructed of hollow clay tile. \*

**Figure 31 South West Rooms Built of Hollow Clay Tile**

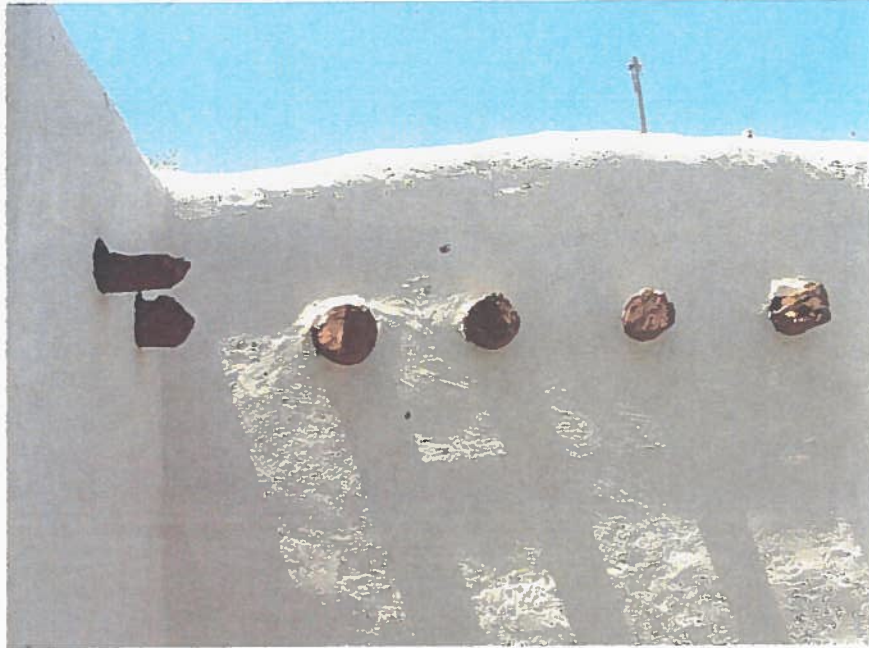
**Figure 32 Typical Cement Stucco Walls**

Cement stucco is the exterior finish material for both the adobe and hollow clay tile block walls of all buildings. The stucco on the adobe building is in poor condition. The adobe walls are being impacted by moisture infiltration. Cement stucco traps moisture in the walls. As a result there are numerous cracks in the stucco that exacerbate the moisture related problems. Asbestos examination has revealed trace elements of asbestos in the plaster samples of the Delphi, Inc. report.

Because of the lack of a uniform attachment base for the stucco and its incompatibility with adobe the condition of the stucco is poor and deteriorating. *This is a serious deficiency.* None of the walls are insulated as per energy code standards. *The rooms are hot in the summer and cold in the winter.*

- 1. A detailed inspection and evaluation of the stucco condition should be conducted**
- 2. Perform site and grading recommendations as listed in the above sections.**
- 3. Remove all cement stucco at areas where stucco appears to be slumped.**
- 4. Remove all cement stucco at any areas where the stucco is loose or where there are major cracks.**
- 4. If possible, remove all the cement stucco from the exterior of the adobe buildings throughout. Since the cement stucco is actually a problem, it would be a good idea to remove it everywhere. The cement stucco is very hard and is adhered to the adobes. Removing the stucco might cause the adobes to crack and fall apart.**
- 5. Replace cement stucco with an approved material, such as a lime-based stucco which will allow the wall to "breathe".**

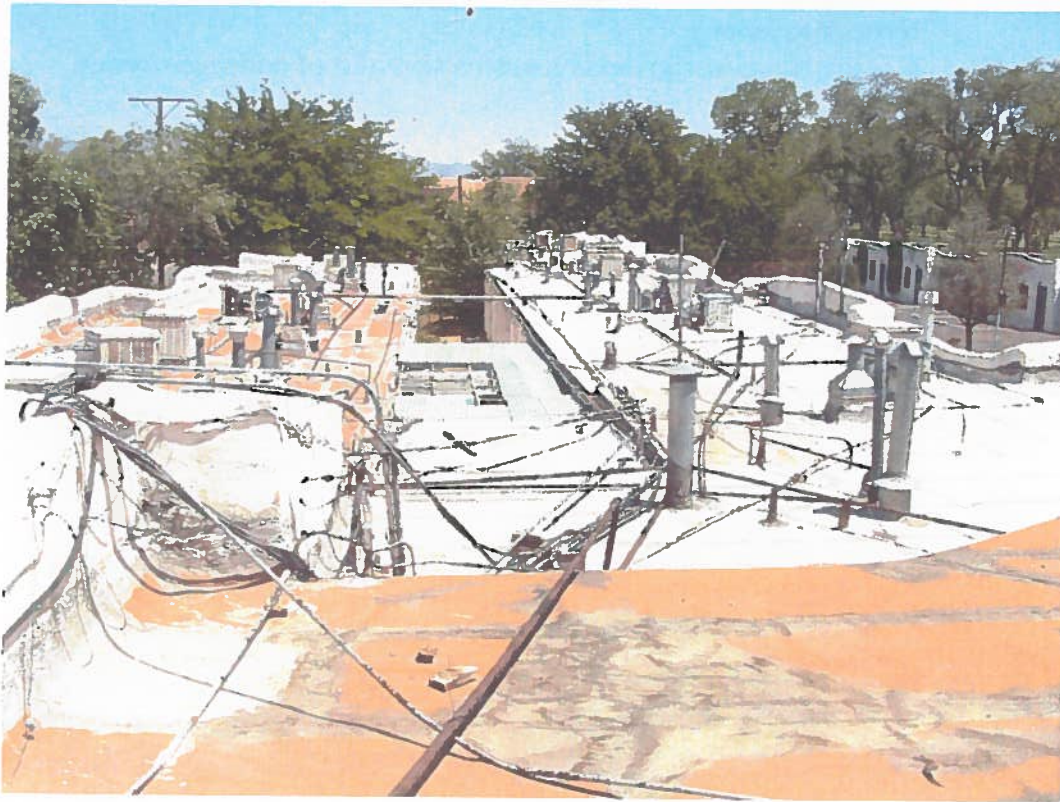
**Figure 41– Roofing Materials at Building 1.**

The El Vado buildings have asphalt based roofing. *The roof surfaces are in fair to poor condition.* Maintenance is required periodically to inspect fasteners, joints and the ridge/parapet connections. The parapet flashing has separated from the walls creating gaps and cracks in the walls. *Areas of particular concern exist at the parapets and perimeter of all building walls. The roof vigas which protruding from the walls are in poor shape due to dry rot conditions*

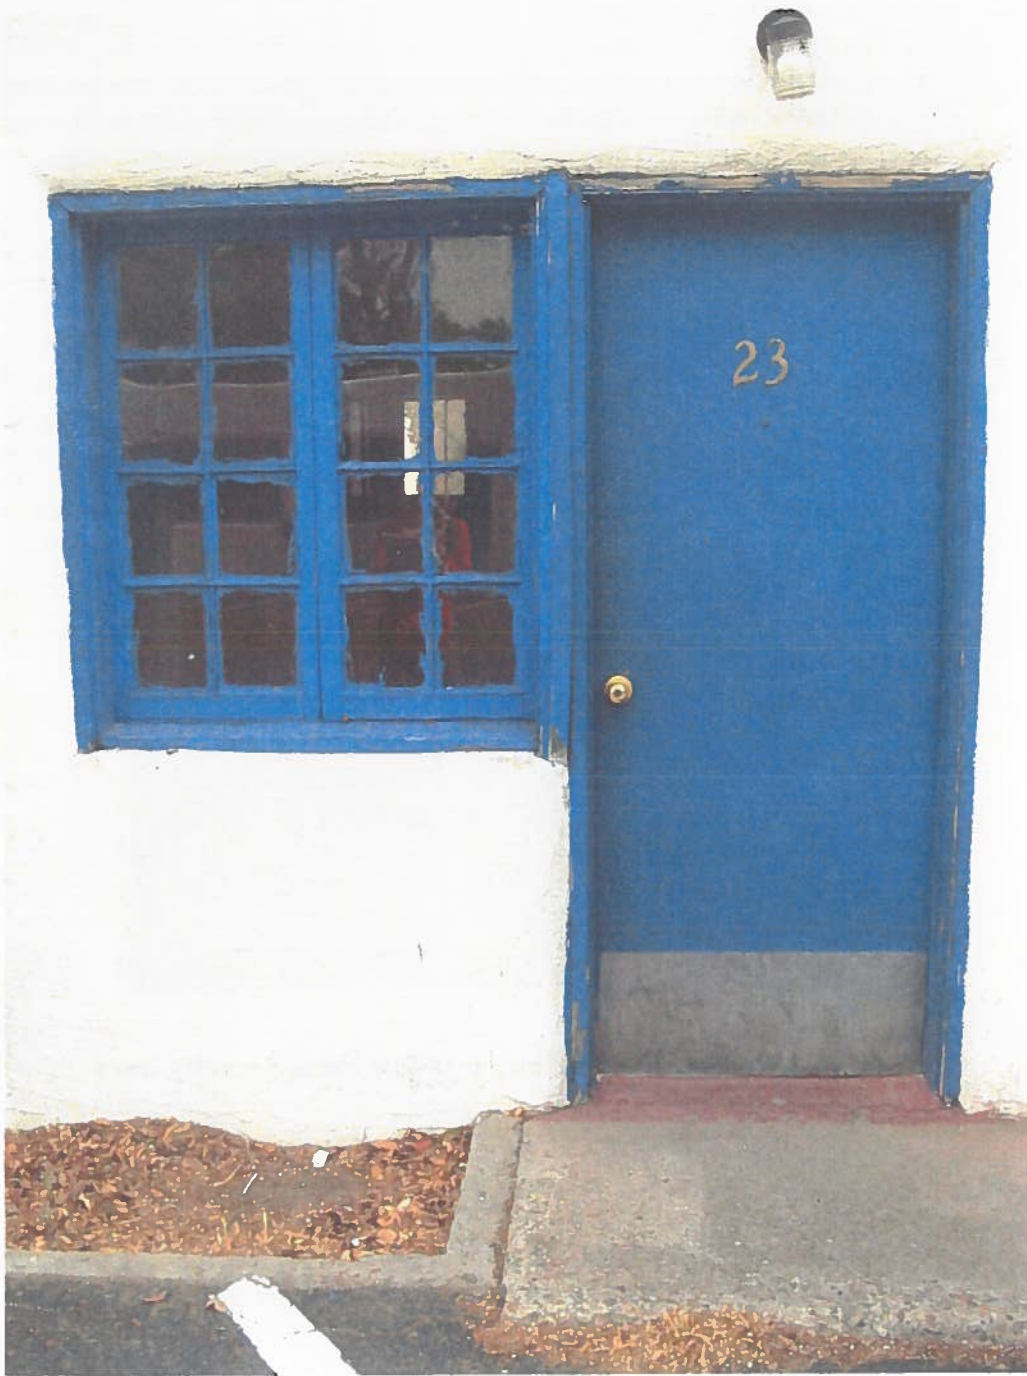
***The overall condition of the windows are poor. Numerous repairs and replacement is required.*** The paint is peeling and is in poor condition. Entry doors and interior doors need refinishing.

**Figure 46 - Multi-pane Window and Typical Wood Exterior Door**
